Octopus Home Inspections, LLC

Your Property Inspection Report

7716 SW 26th Ave, Portland, OR 97219
Inspection prepared for: Don & Sherri New
Real Estate Agent: -

Date of Inspection: 6/8/2016 Time: 0:00 PM
Age of Home: 1966 Size: 2638
Weather: Sunny, Dry
Order ID: 89

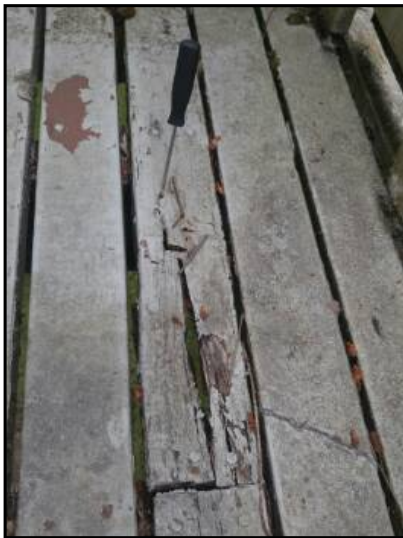
Wood rot observed on deck surface

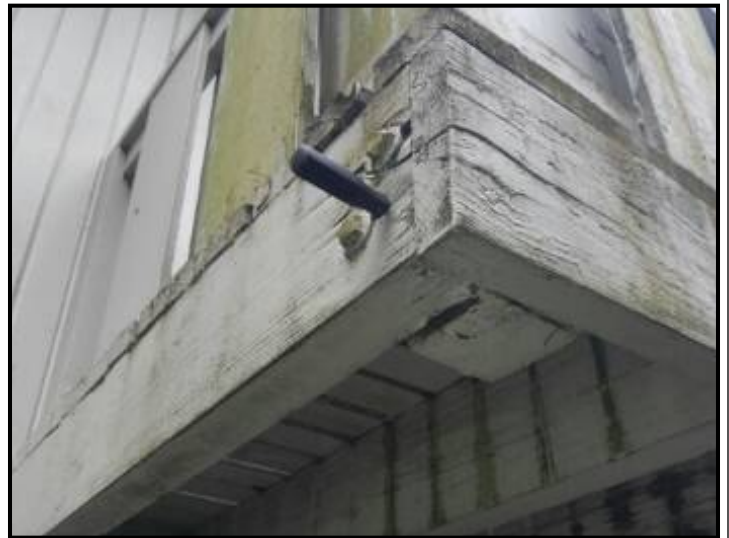
Wood rot at ends of support framing

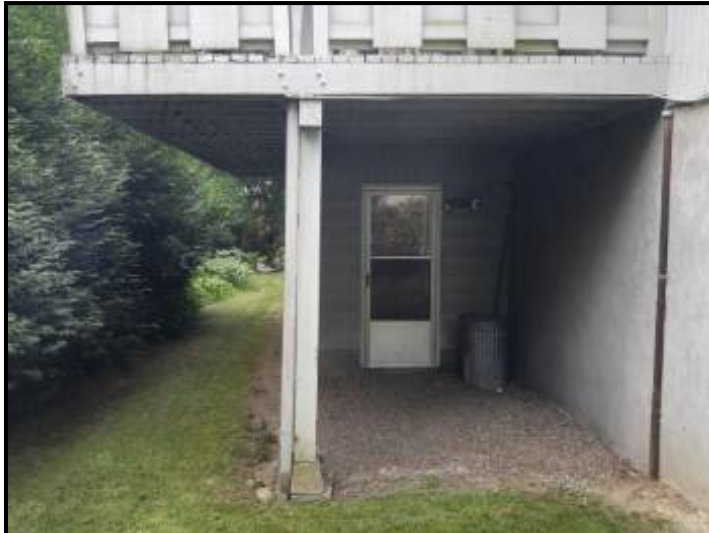
Support beam does not appear to be fastened to the pier pad below.

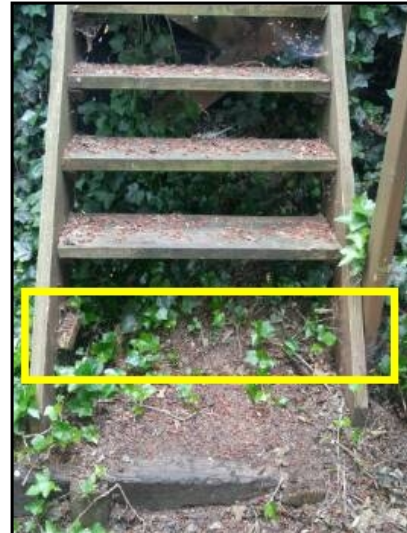
Step missing at exterior steps

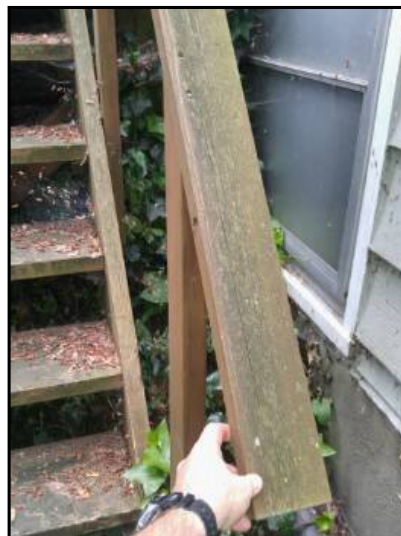
Handrail wobbly and only installed on one side. Safety concern

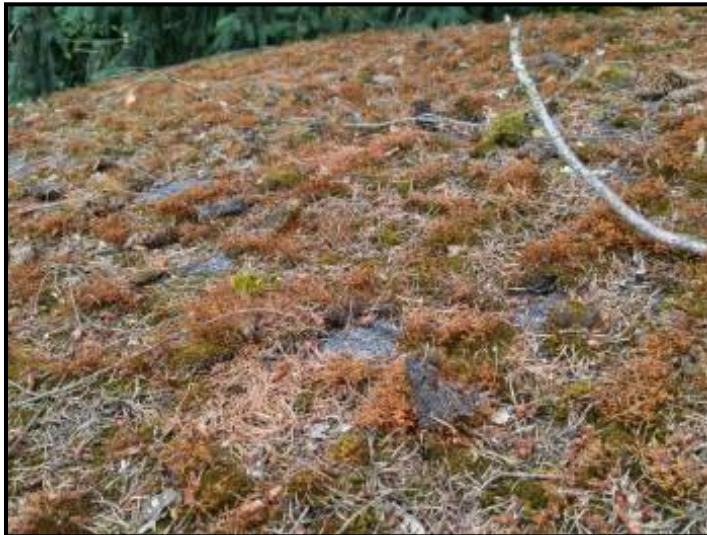
Large amount of organic debris on roof from adjacent trees to the south

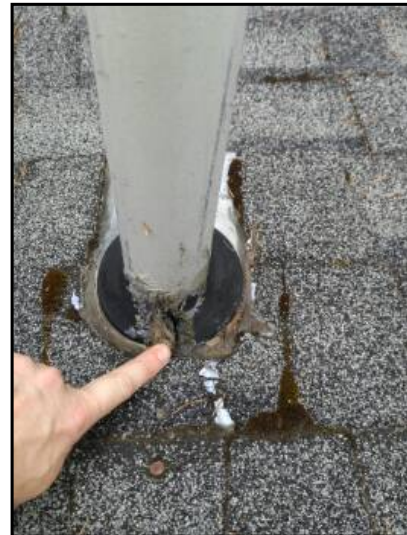
Flashing at base of electric mast is cut and sealant has failed

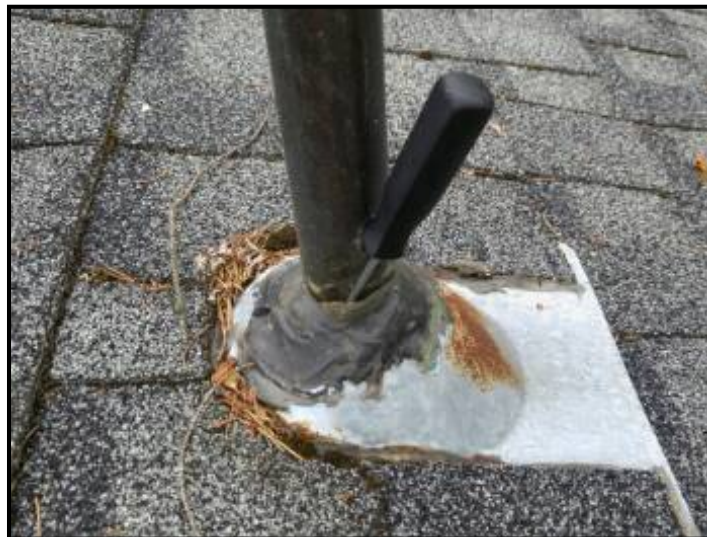
Flashing boots around plumbing vents are broken

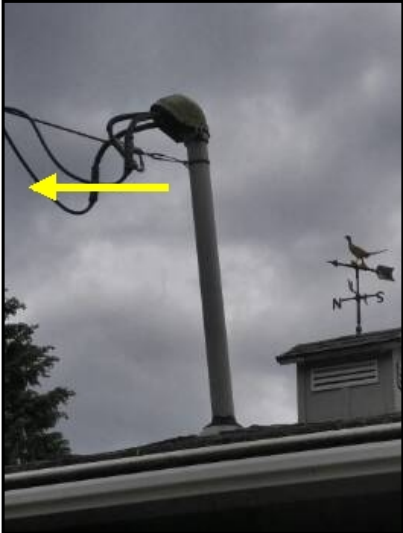
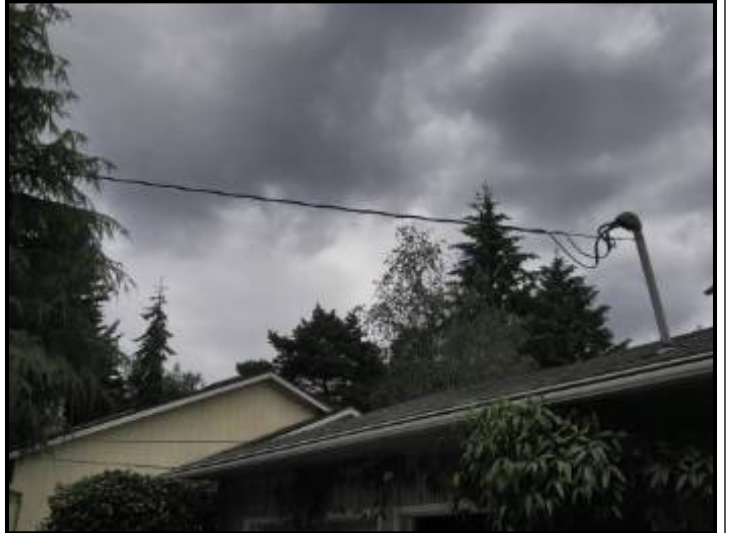
Page 32 Item: 2	Service Entrance	<ul style="list-style-type: none">• Electrical service mast on roof is leaning or bent. The service lines coming to the house from the adjacent pole is taught. The inspector believes there has been a shift of some sort taking any slack in the high voltage line away and the result is the metal mast coming up from the house to receive the wires is now bending in order to hold the wires. Highly recommend having the power company out to review the situation soon.

Electric service mast is bent		Electric service line has no slack.
Page 33 Item: 6	Branch Circuit Wiring	<ul style="list-style-type: none">• Double tapping (double lugging) can create hot spots on breakers and neutral bars because they are not tightened to the correct torque--especially if two different size conductors are used. Because the hot [black] and neutral [white] wires are both current carrying conductors, the chance is then greater for potential hot spots. If the double tap or lug becomes loose, it begins to arc. As it arcs it builds up carbon. Carbon is then resistance and with more carbon buildup the more difficult it is for the conductor to make contact—thus increasing the current. The end result can be the breaker tripping because of the loose connection [current exceeding the rating of the breaker], or signs of overheating such as discolored wires, melted wires or fire. Recommend having a professional electrician evaluate further.

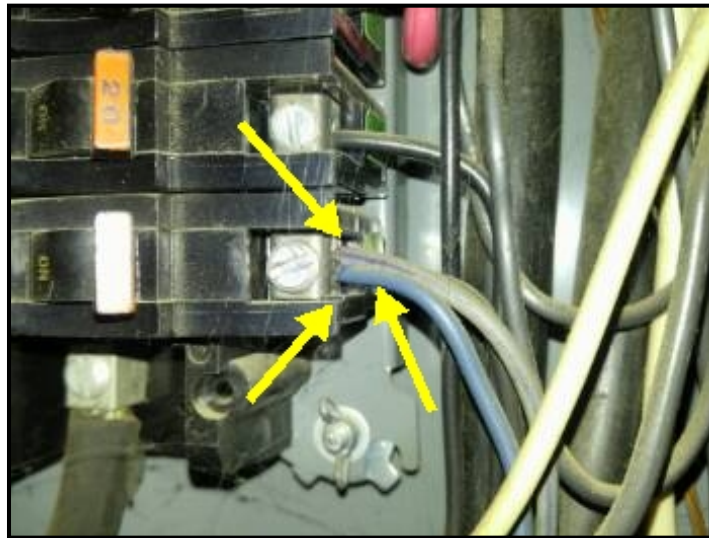
TRIPLE tapped breaker

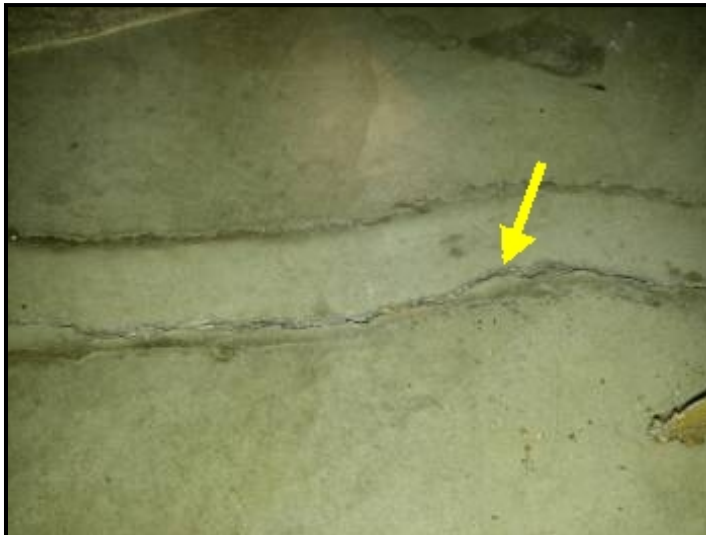
- A notable crack was observed on the basement floor near the fireplace. The crack had been repaired in the past but has continued to grow. Recommend hiring a structural engineer to evaluate further in order to stop and repair cracking in floor.

Large crack in basement floor appears to be recent. Repair made previously.

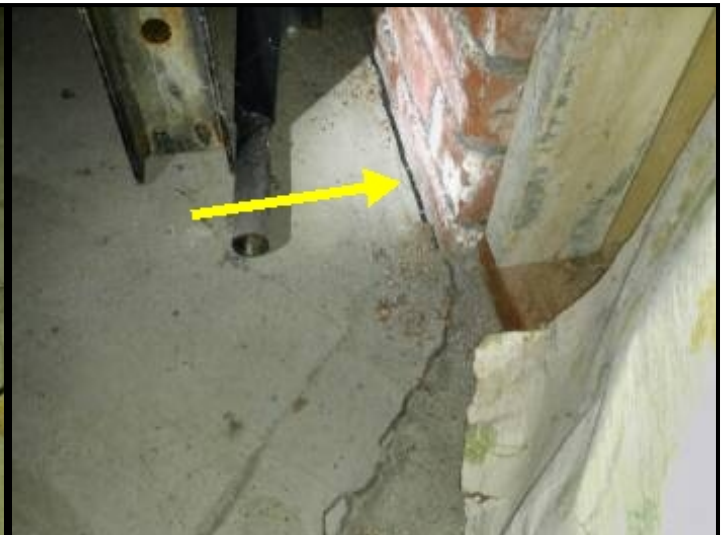
Cement slab is separating from chimney bricks

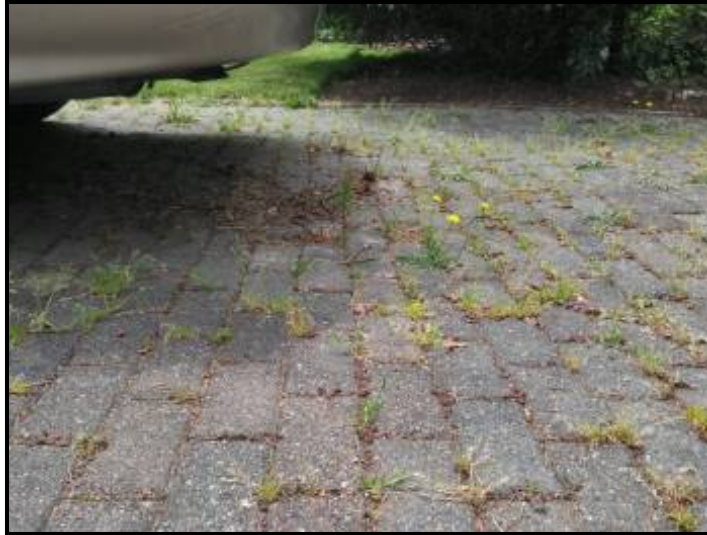
- Sunken areas on brick driveway.
- Front entry walk is slightly higher in elevation than the surface of the driveway. Recommend highlighting transition to avoid accidental tripping hazard.

Sunken areas on brick driveway. Vegetation growth observed

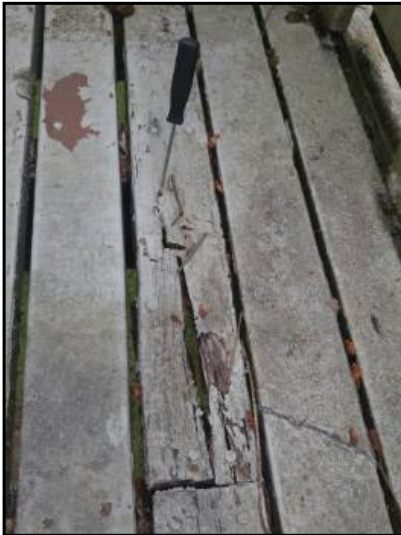
- **Rotted deck treads observed. Recommend replacing. Make sure to leave a gap of 3/8 inch between boards to allow water to drip through and deter wood rot.**

Wood rot observed on deck surface

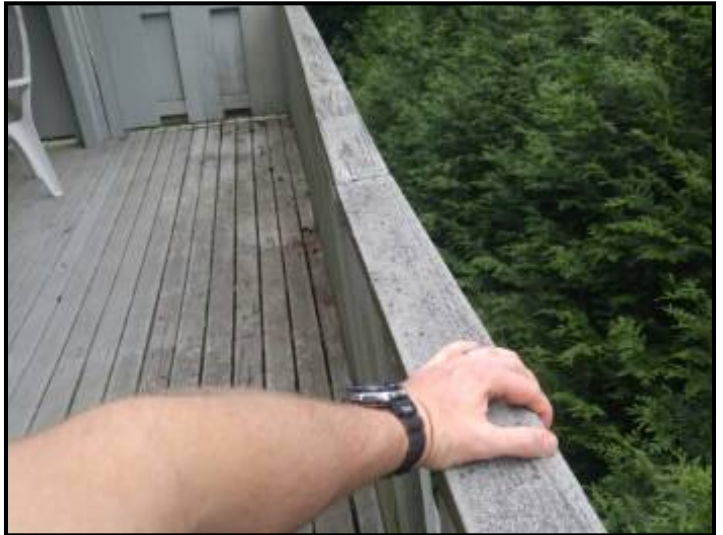
- **Deck railing not secure. Recommend repair by a licensed contractor.**

Railing is not secure

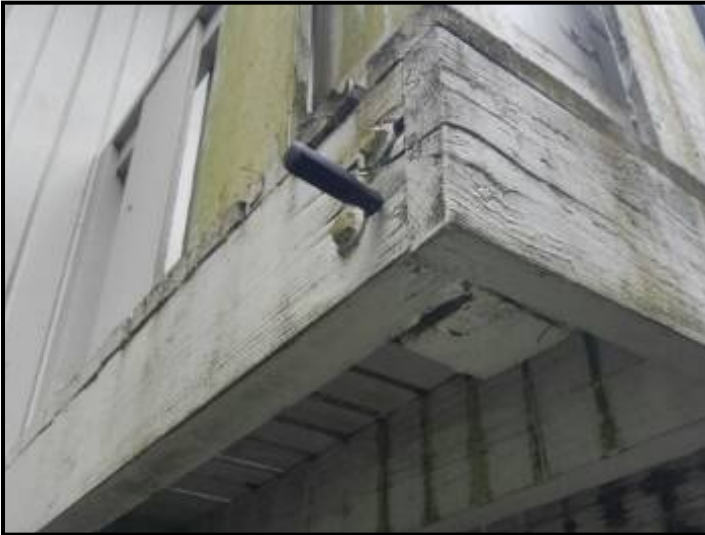
- **Wood deterioration noted. Have repaired as necessary by a licensed professional. Keep sealed with paint or stain for longevity of use.**

Wood rot at ends of support framing

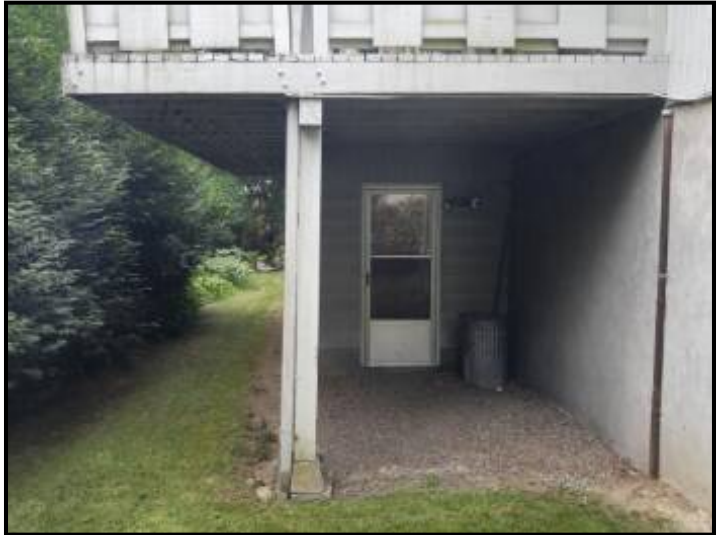
- Deck support does not appear to be mechanically fastened to the support post at the base where the wood post meets the cement pier pad. Recommend having this detail reviewed when the deck is rebuilt.

Support beam does not appear to be fastened to the pier pad below.

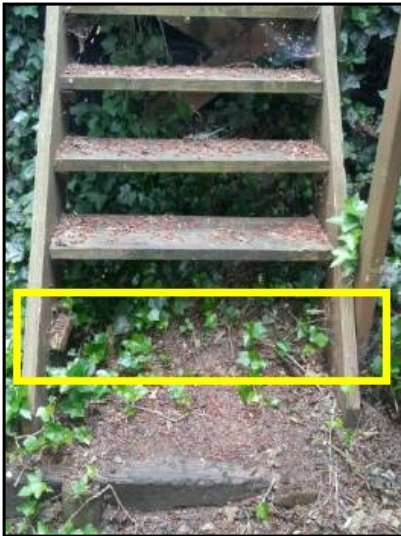
- **Broken / missing step(s).**

Step missing at exterior steps

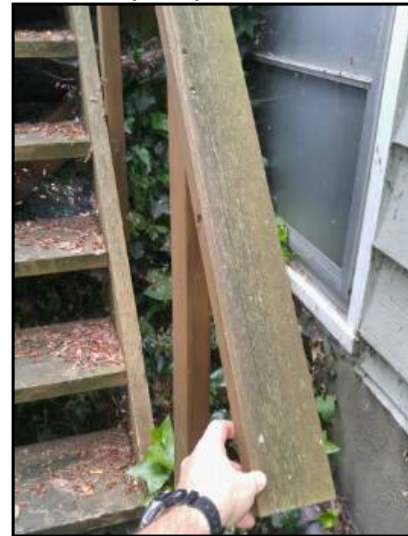
- The steps to the south of the home are in compliance with a handrail on at least one side of the stairs, but the side that does not have a railing also has a longer drop off. Recommend adding an additional handrail on the south side of the exterior stairs for safety.

Handrail wobbly and only installed on one side.
Safety concern

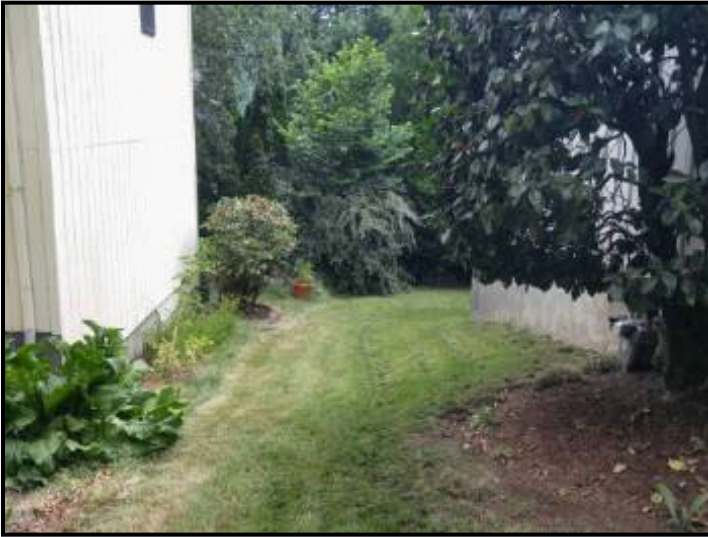
- Grading around house is uneven. Portions of the land surrounding the home are sloped toward the house channeling water towards the foundation when it rains.
- House is built on a slope. Attention should be kept to assure water is draining around the foundation. A french drain may be a good addition to usher surface drainage around the foundation.

House is built on a slope.

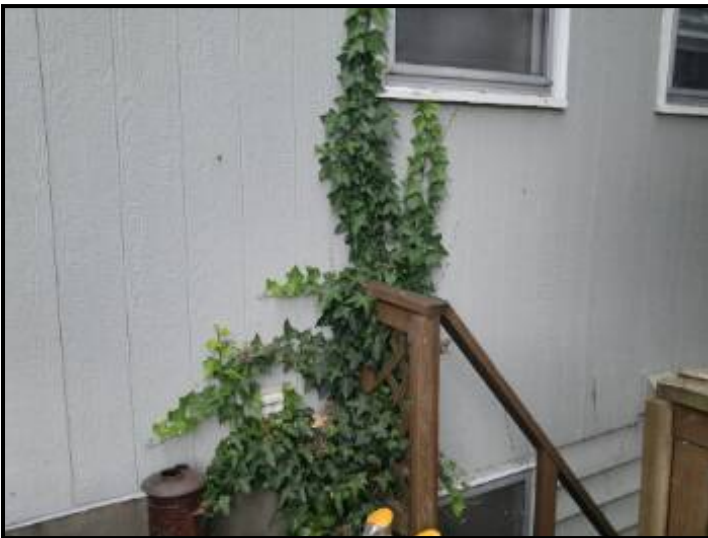
Ivy growth on siding observed

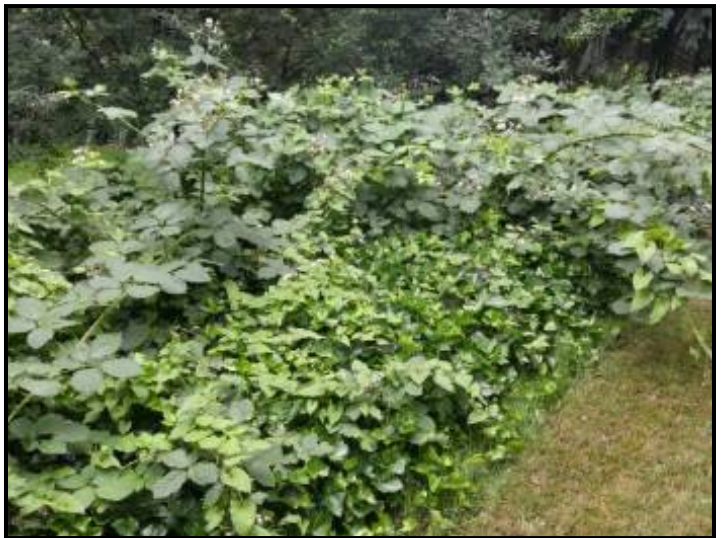
- Blackberry vines noted growing in yard. This is often considered to be an unwelcome and invasive species. Recommend removal of growth and roots.
- Overgrown Ivy noted growing in yard near house. This is often considered to be an unwelcome and invasive species. Recommend monitoring and not allowing to grow on structure itself.
- Tree limbs within 10 feet of roof should be trimmed away to provide air and sunlight to roof, while minimizing debris & dampness. Recommend trimming trees
- Clematis vines growing on structure. These vines are always looking for a strong hold. Make sure your siding and roof are not it. They will grow into the wall cavities and under roof shingles in order to hold on. This could be damaging to the structure.

Blackberries growing in yard

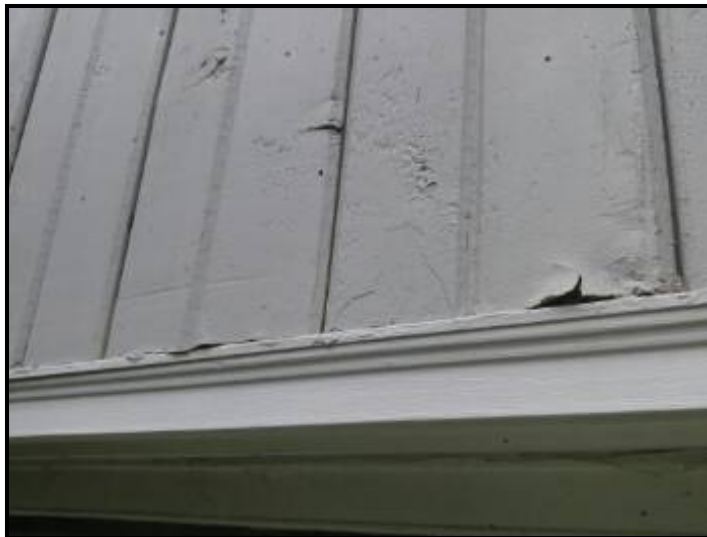
- Warped siding present in some areas; recommend repair or replacement as necessary.
- Rot or potential rot observed on exterior siding. Recommend having affected areas removed and replaced, caulked and painted to match the rest of the siding.
- NOTE: Peeling paint is often caused by poor preparation of the surface prior to painting. Cracking may be caused by old age, and the expansion and contraction of the wood. Blistering could be caused by moisture.

Siding paint peeling above window and door frames

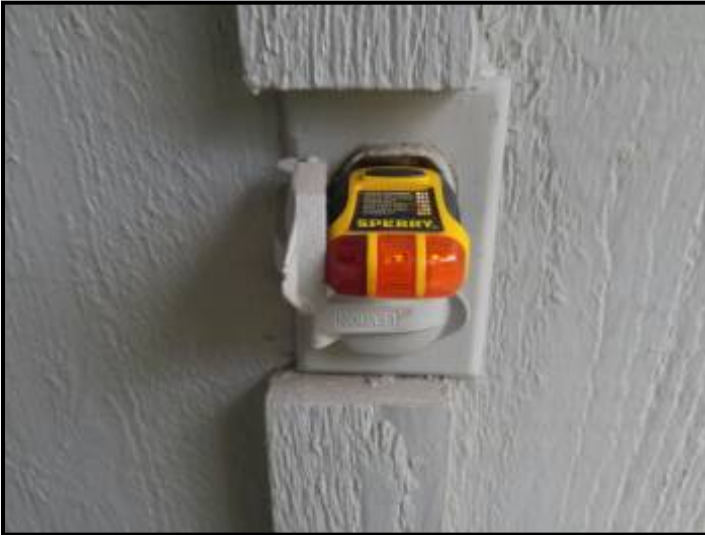
- **GFCI** trip test failed.
- Exterior lights operate using either a motion or ambient light trigger and could not be tested at time of inspection. Ask seller to demonstrate operation at final walkthrough.
- Service mast is bent. Contact the local electrical provider for repair or replacement.

Exterior outlets are not GFCI Protected

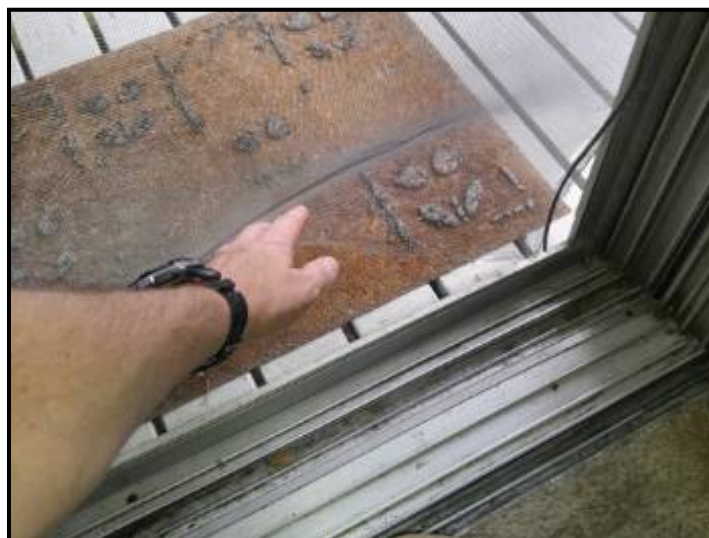
- Sliding Screen door torn. Recommend having it repaired.
- Basement doors are interior Hollow core doors. Recommend having them upgraded to steel doors with a foam core for security and energy efficiency.
- All exterior doors operated correctly at time of inspection.

Sliding door screen is broken

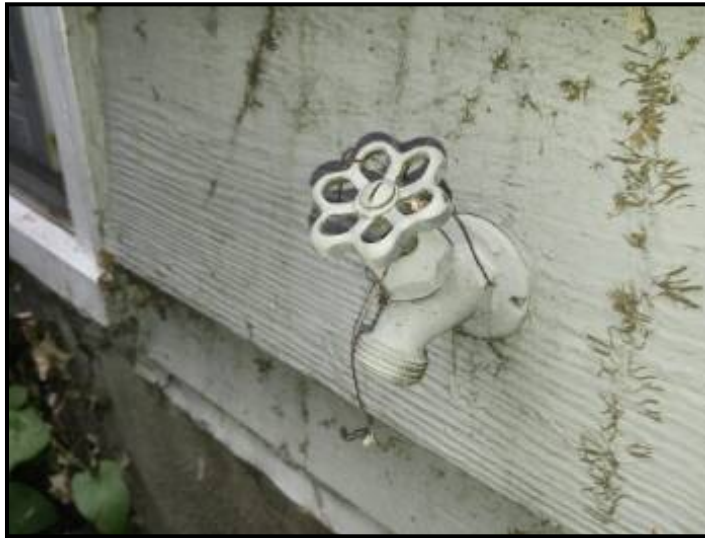
- Numerous exterior faucets were turned off at interior shut-offs. Inspector did not operate interior shut off valve in case the valve was closed for a leaking pipe, joint or faucet. Ask seller to demonstrate at final walk through.
- Exterior hose bibs were winterized at time of inspection. Inspector did not operate.

Exterior house bibs are shut off from interior at rear of house

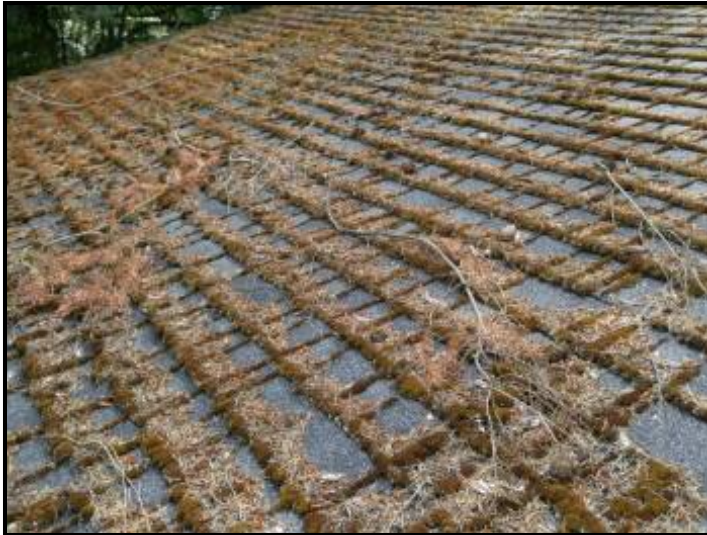
- Walked roof for inspection.
- Moss on roof. This can lead to the premature failure of the roof and subsequent leaks. Recommend treating moss during its growing season (wet months) with a moss killer.
- Worn shingles observed. This needs to be further reviewed by a licensed roofer.
- **Flashing**s are rusted. Recommend replacement
- **Significant amounts of organic debris evident. Recommend cleaning roof covering to discourage moss growth and moisture retention.**
- **One or more roof penetrations have been sealed with tar or mastic instead of conventional metal or plastic flashings. Leaks may develop over time as the sealant deteriorates. The penetrations will need to be diligently monitored for leaks and periodically re-sealed. Replacement of the flashing is a better alternative and is recommended.**

Heavy moss growth on roof

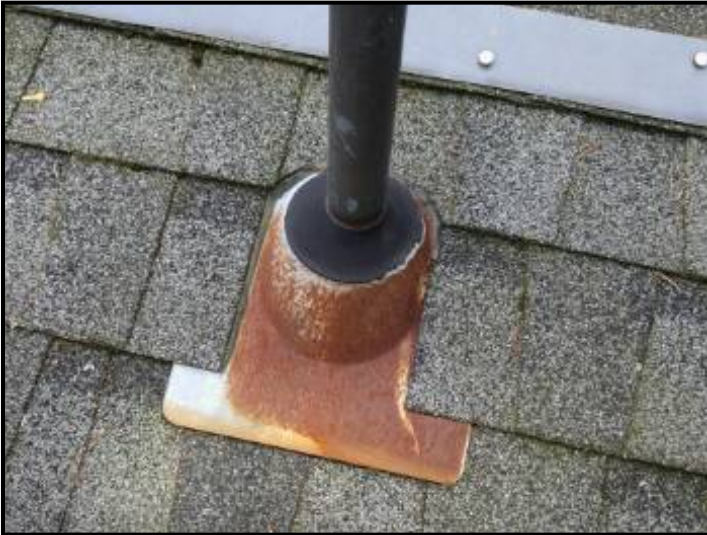
Flashing around plumbing vents is rusted

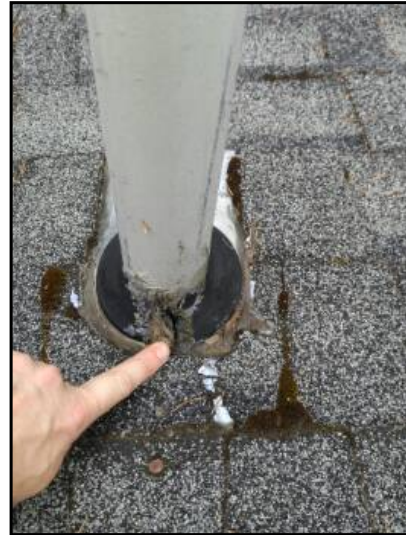
Flashing at base of electric mast is cut and sealant has failed

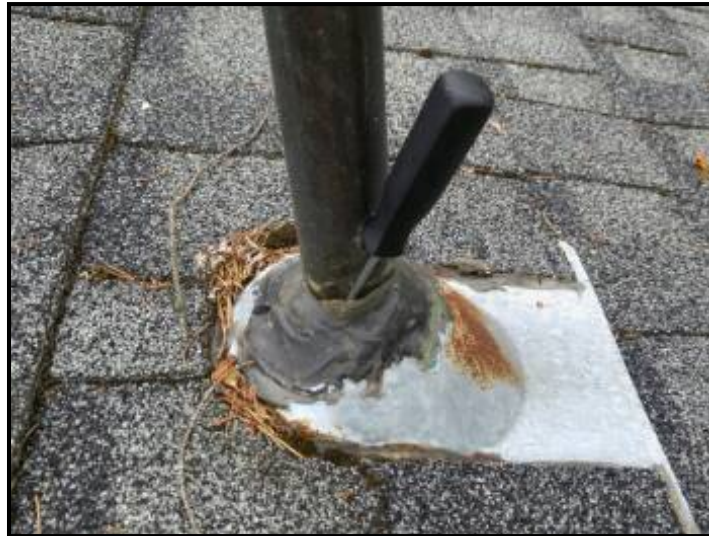
Flashing boots around plumbing vents are broken

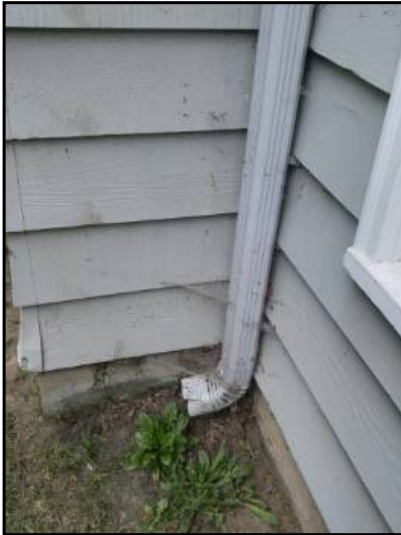
- Down spouts appear to be attached to underground piping. Termination of these pipes is unknown.
- Leaf guard installed on gutters.
- At least one downspout discharge above grade. Splash blocks or extensions should be installed to help move the roof's watershed away from the foundation.

Downspout terminates at base of foundation

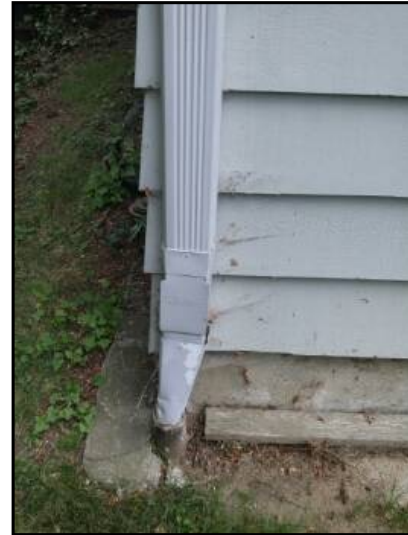
Most downspouts are attached to underground piping.

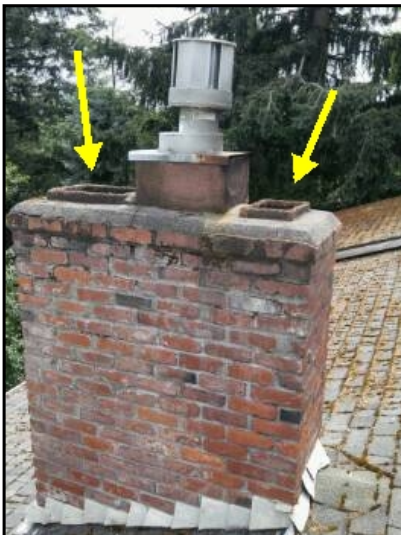
- No Spark Arrestor installed on chimney. This is a potential fire hazard. Recommend having a spark arrestor installed on chimney
- Cement chimney cap cracked or broken. Recommend repair or replacement to prevent premature weathering.
- Moss growth observed on chimney. Recommend clearing to avoid further moisture damage to brick and mortar.
- Step cracking observed through mortar around bricks. recommend having a specialist inspect further for potential repairs.
- Chimney Mortar shows sign of deterioration. Recommend having repaired as necessary.
- Bricks showing signs of wear. Appear to be **spalling** due to freeze and thaw cycles in the colder months. Recommend further inspection and repair by a licensed professional.

Spark arrestors missing

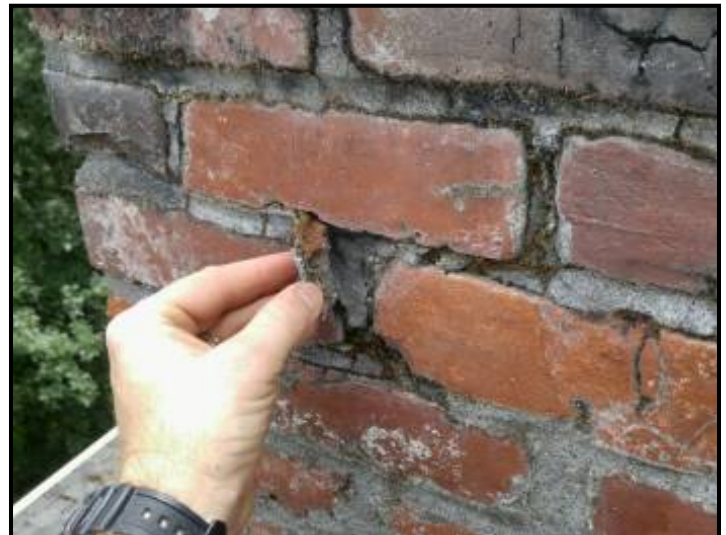
Mortar is cracked and broken around bricks.

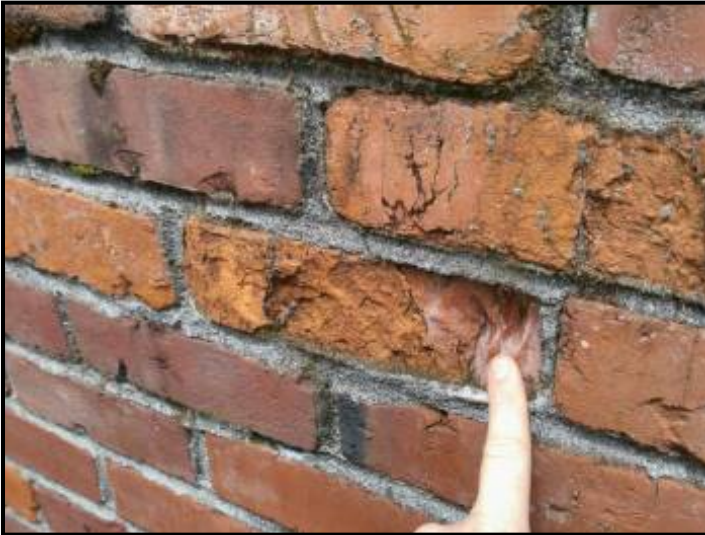
Bricks have spalling damage from freeze thaw cycles

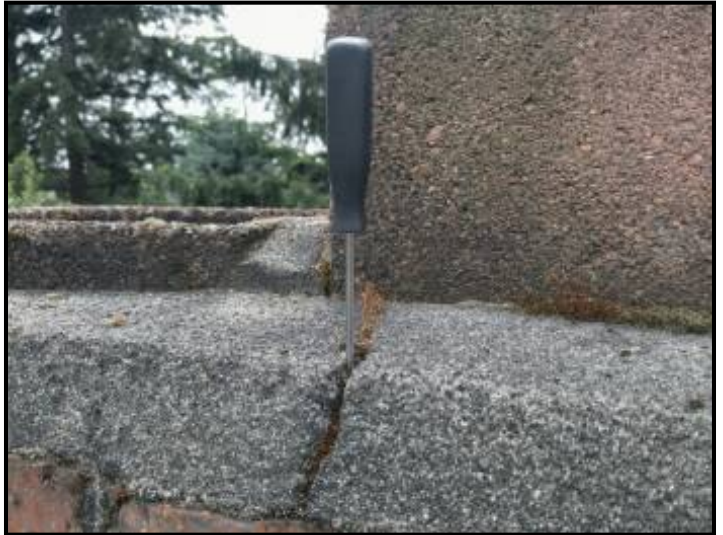
Chimney cap cracked and worn away at edges

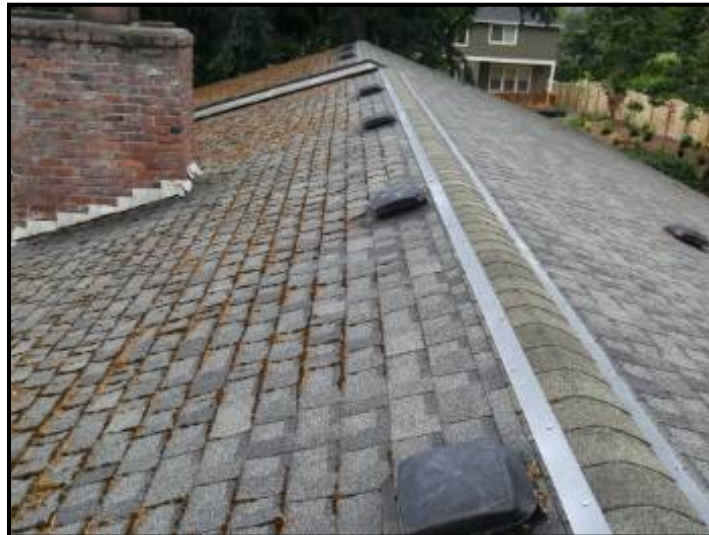
- Attic ventilation is low with reference to the square footage of the attic space below. Recommend increasing attic ventilation on both the upper and lower portions of the roof.

Upper attic ventilation installed

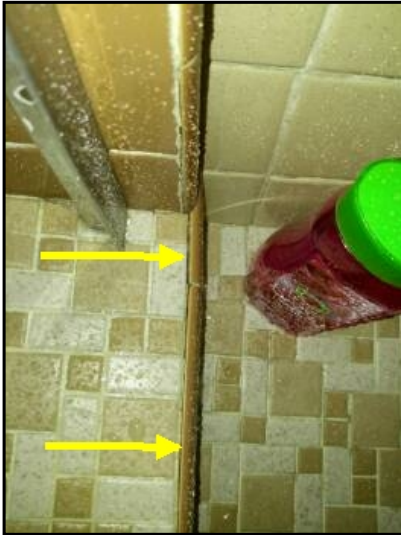
- No GFCI outlets visible, which is common for a home of this age. Consider having protective outlets installed.
- Sink drains slowly. Recommend clearing drain.
- Cracked tile(s) noted in shower. Could be a sign of moisture intrusion and swelling.
- Sink drain pipe is made of chrome dipped brass. It showing signs of corrosion and should be replaced soon. Recommend installing a longer lasting product such as black **ABS** or white **PVC**.

Tiles detached in master shower. Tile are loose to the touch

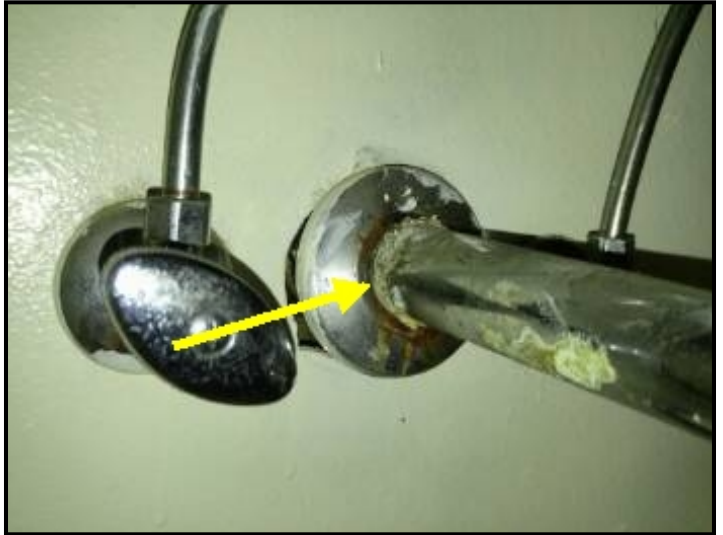
Corroded drain under master sink. Replace soon

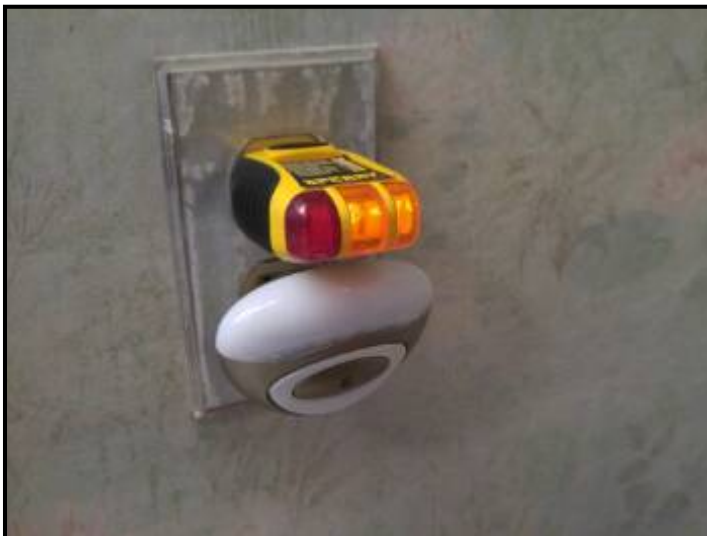
- No GFCI outlets visible, which is common for a home of this age. Consider having protective outlets installed.
- Tub/Shower drains slowly. Recommend clearing drain.
- Tub/shower area needs caulk / grout.
- Tub - floor junction needs caulk / grout.

Outlets above sinks are not GFCI protected

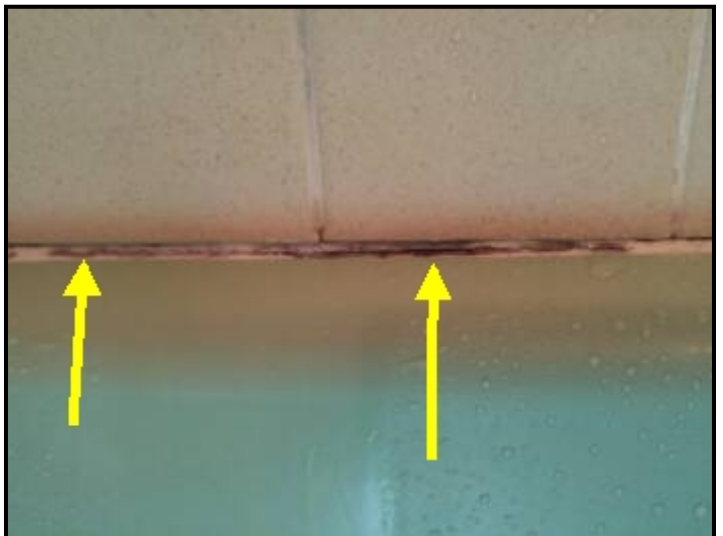
Black staining and breaks observed in bathtub caulking

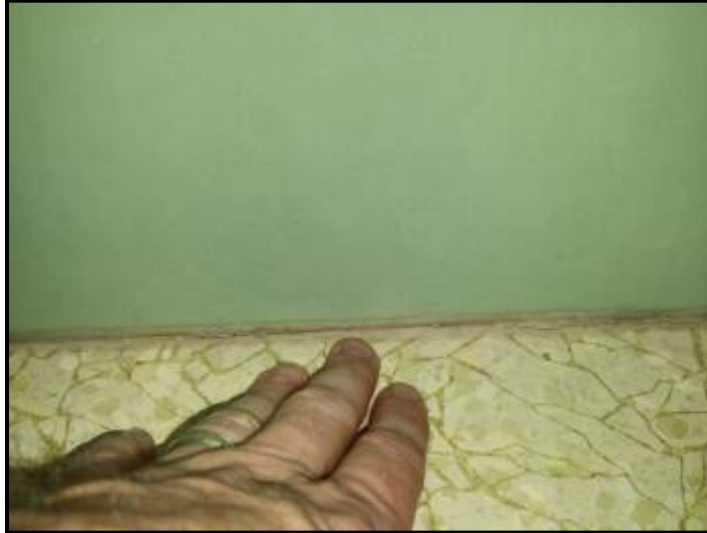
Caulking broken at tub/floor connection

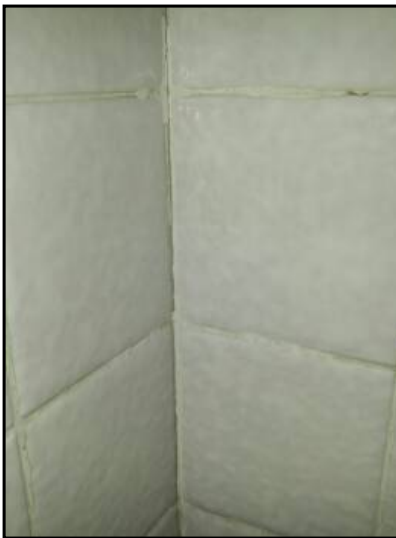
- Tub/shower area needs caulk / grout.

Crack in grout or caulking in basement shower.

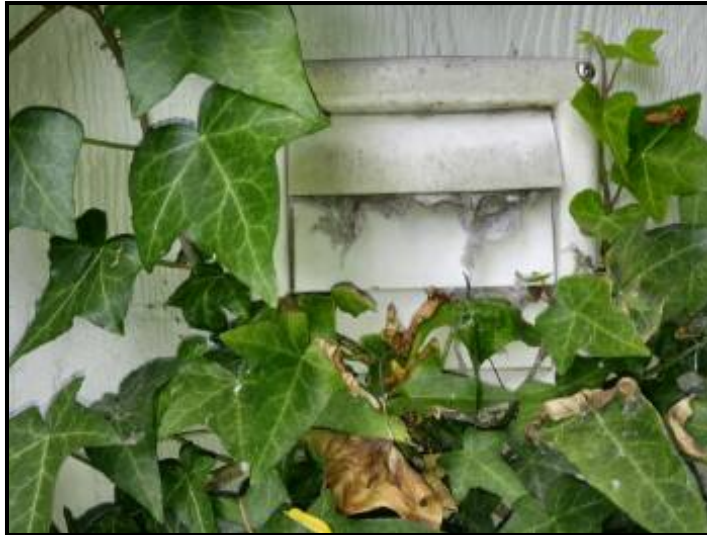
- Washing machine operated as designed using normal controls
- Clothes dryer operated as designed using normal controls
- Dryer vent pipe is clogged with lint. Recommend cleaning out for proper dryer function and energy savings.
- Dryer vent has a blocked exterior cover. Recommend clearing ivy vines for better exhaust and quicker drying time.

Ivy is blocking laundry vent. Entire vent pipe and termination cover is clogged with lint

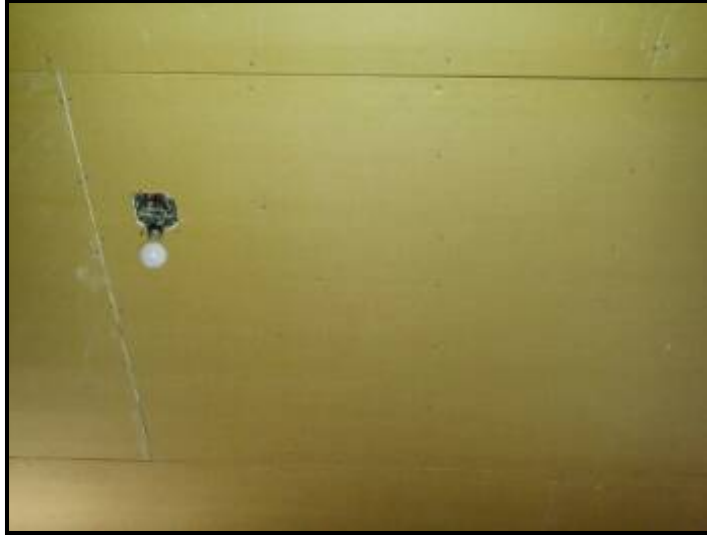
- Unfinished drywall ceiling in basement.
- General condition of ceilings appeared satisfactory.

Drywall not finished in basement room

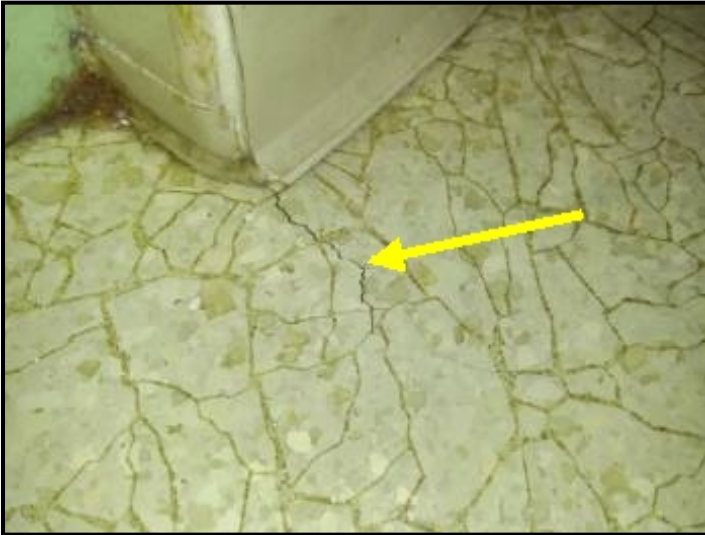
Crack in linoleum floor in bathroom.

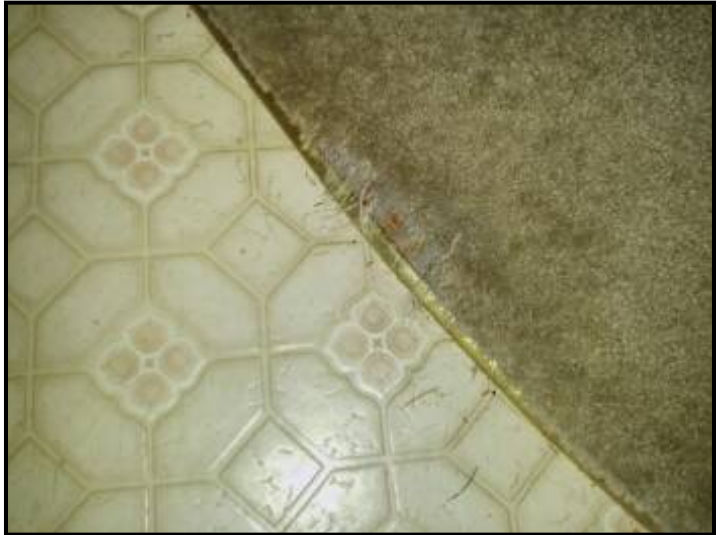
Carpet torn at front entrance.

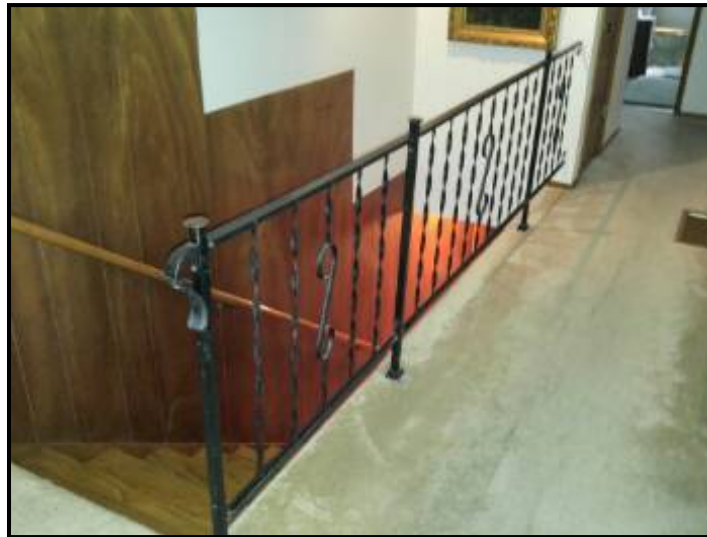
- Spindles at stairwell exceeds 4 inch spacing, which is considered safe by today's standards.
- Loose railing at top of stairs. Repair as needed.

Railing may not be secure enough.

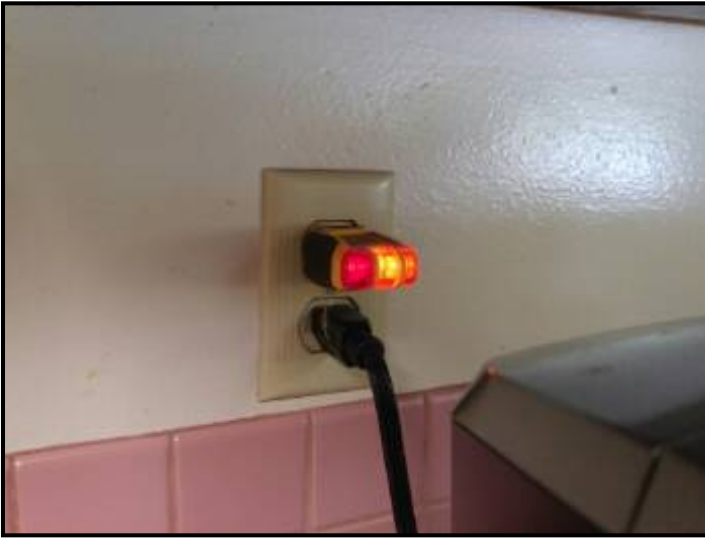
- GFCI outlets not installed near water receptacles. Although this configuration is area specific for the time when the house was constructed, today's standards recommend installing these type of outlets within 6 feet of a water fixture.
- Switch damaged in hall bathroom. Recommend replacement
- Junction Box Cover(s) missing. This is a potential shock or electrocution hazard. Recommend having a professional electrician make repairs
- Outlet cover(s) missing. Replacement necessary to avoid accidental contact with live wiring.
- Romex wiring should all be enclosed in conduit for protection from nicks or cuts which could be a source of shocks or even electrocution.
- Light fixture broken. Recommend replacement

GFCI outlets not installed near water fixtures

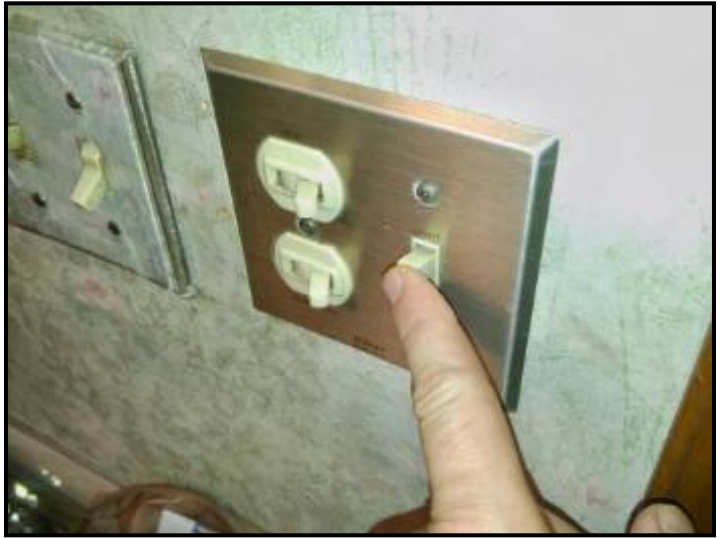
Light switch in hall bath is very loose.

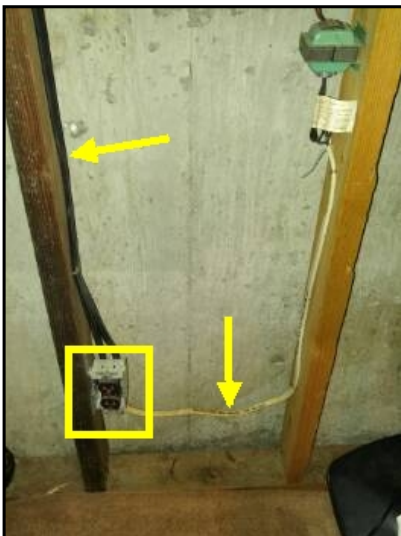
Out cover missing and romex wire not protected from accidental contact.

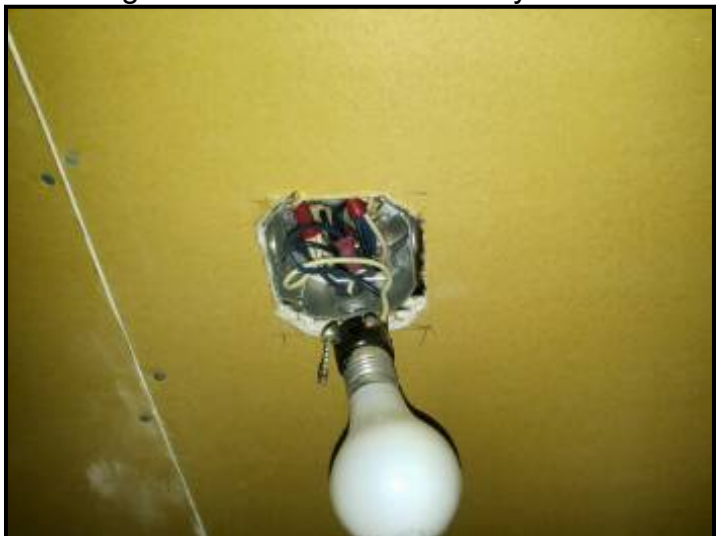
Junction box cover missing. Light fixture hanging by wires.

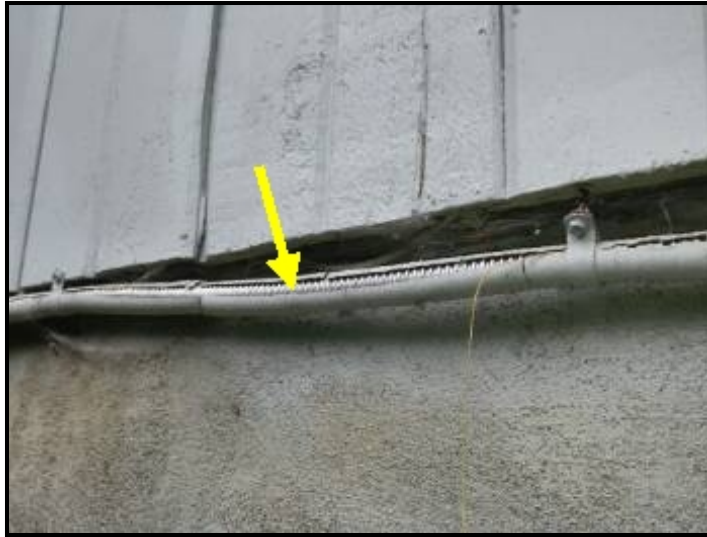
- Natural gas line to upper gas fireplace insert has been degraded by the sun and the outer jacket has torn. This product was not rated for exterior use and should be evaluated by a licensed professional. Recommend either running new line on the interior or using black steel pipe on the exterior.

Gas line to fireplace is not rated for outdoor use. Protective coating has broken.

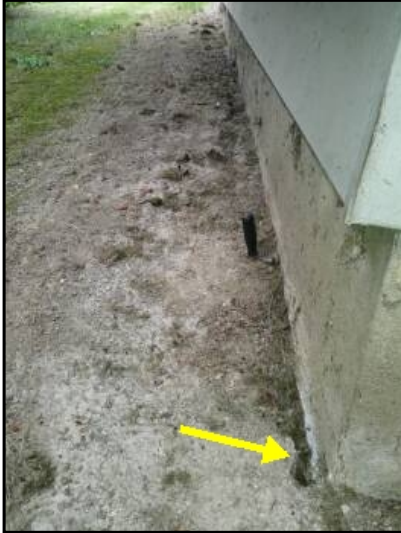
- Evidence of insect activity and/or insect traps in house. Recommend evaluation by licensed pest control specialist/exterminator.

Potential pest tunnels at base of foundation. Soil is very hollow

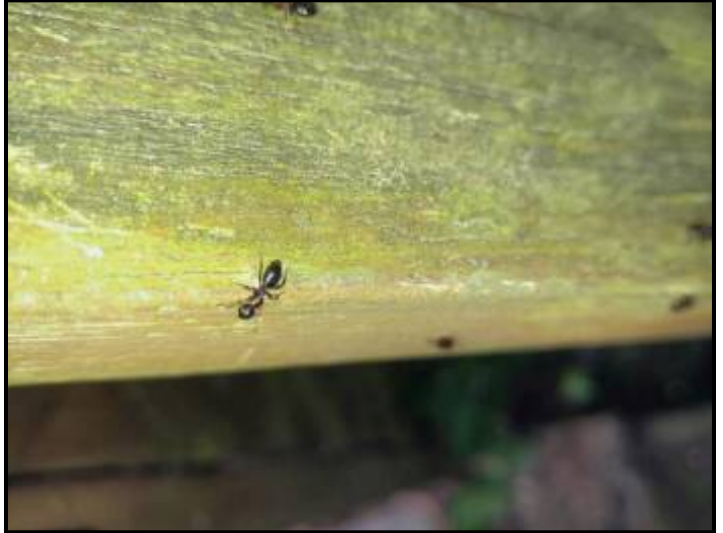
Ants observed in various locations

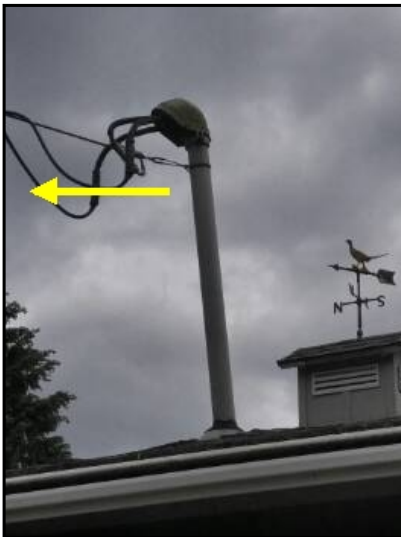
- Overhead Service
- **Electrical service mast on roof is leaning or bent. The service lines coming to the house from the adjacent pole is taught. The inspector believes there has been a shift of some sort taking any slack in the high voltage line away and the result is the metal mast coming up from the house to receive the wires is now bending in order to hold the wires. Highly recommend having the power company out to review the situation soon.**

Electric service mast is bent
