Octopus Home Inspections, LLC

Your Property Inspection Report

7716 SW 26th Ave, Portland, OR 97219
Inspection prepared for: Don & Sherri New
Real Estate Agent: -

Date of Inspection: 6/8/2016 Time: 0:00 PM
Age of Home: 1966 Size: 2638
Weather: Sunny, Dry
Order ID: 89

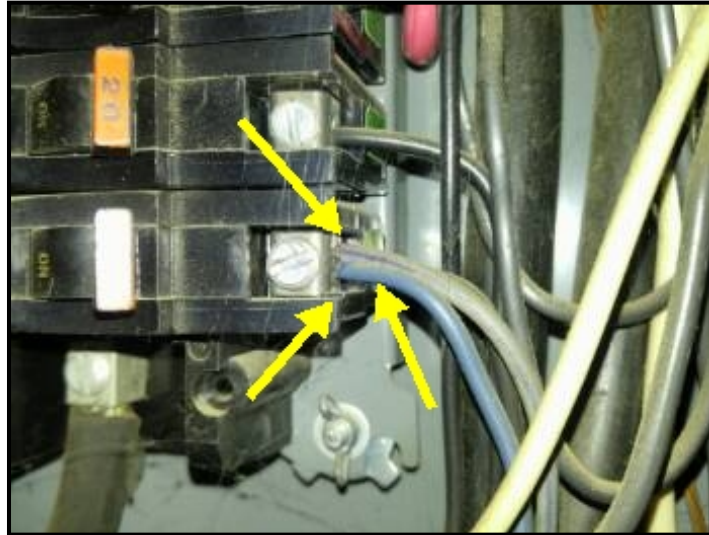
- Branch Circuit wiring: Aluminum
- **Double tapping (double lugging) can create hot spots on breakers and neutral bars because they are not tightened to the correct torque--especially if two different size conductors are used. Because the hot [black] and neutral [white] wires are both current carrying conductors, the chance is then greater for potential hot spots. If the double tap or lug becomes loose, it begins to arc. As it arcs it builds up carbon. Carbon is then resistance and with more carbon buildup the more difficult it is for the conductor to make contact—thus increasing the current. The end result can be the breaker tripping because of the loose connection [current exceeding the rating of the breaker], or signs of overheating such as discolored wires, melted wires or fire. Recommend having a professional electrician evaluate further.**

TRIPLE tapped breaker

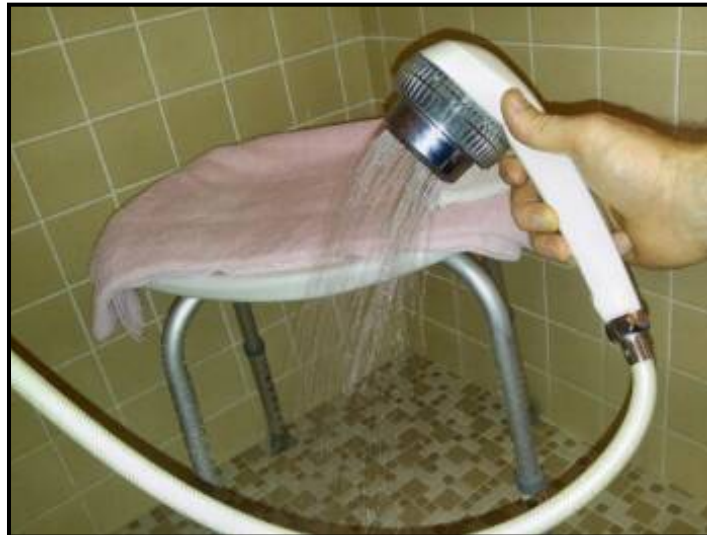
- Copper
- Cold water pressure decreases significantly when more than one water fixture is used on the south side of the house. The inspector believes the water lines are ok, but he doesn't think the 1/2 inch copper pipe size is allowing for enough water to flow to more than one cold water fixture at a time. All plumbing branches and connections are hidden behind finished walls. Recommend having a plumber investigate further.

Noticable pressure loss when more than one cold water fixture is in use

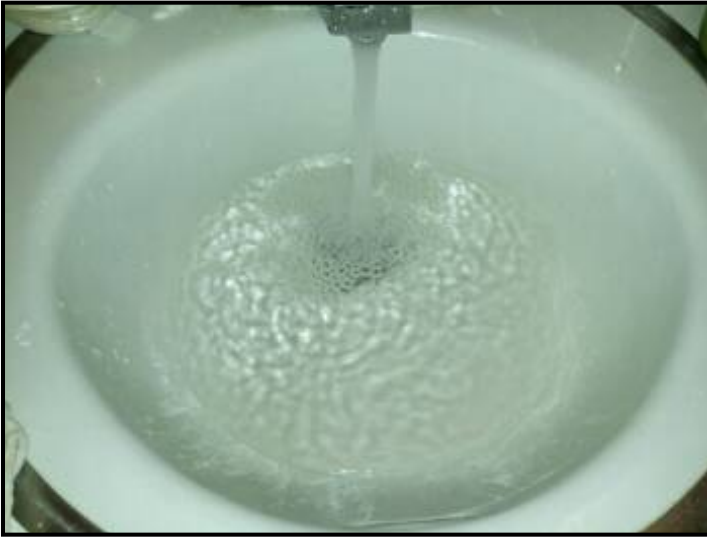
- Slow, less than functional drainage observed in bathrooms. Repair as needed.
- A slow draining sink in a bathroom is normally due to a clogged trap. Disassembly and cleaning of the trap is the most effective correction. Plumber recommended.

Master sink drains slowly.

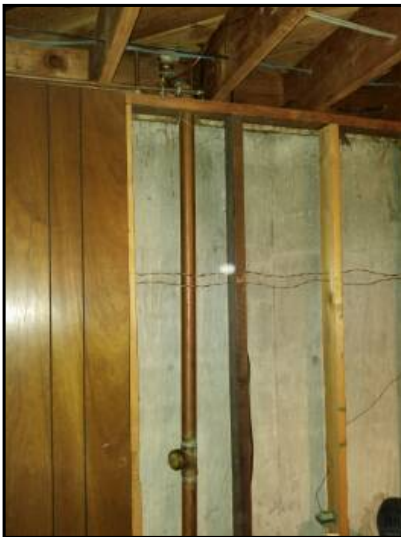
Waste plumbing is made of copper tubing.

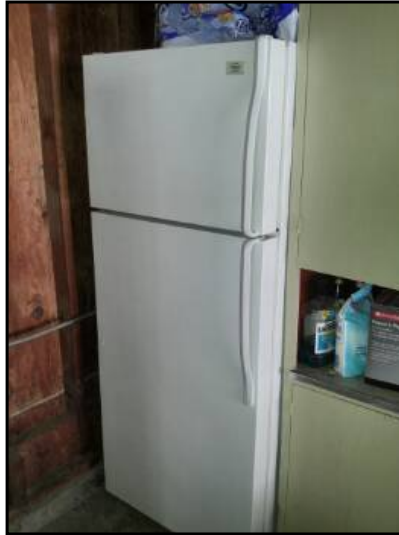
Refrigerator not operating correctly in garage

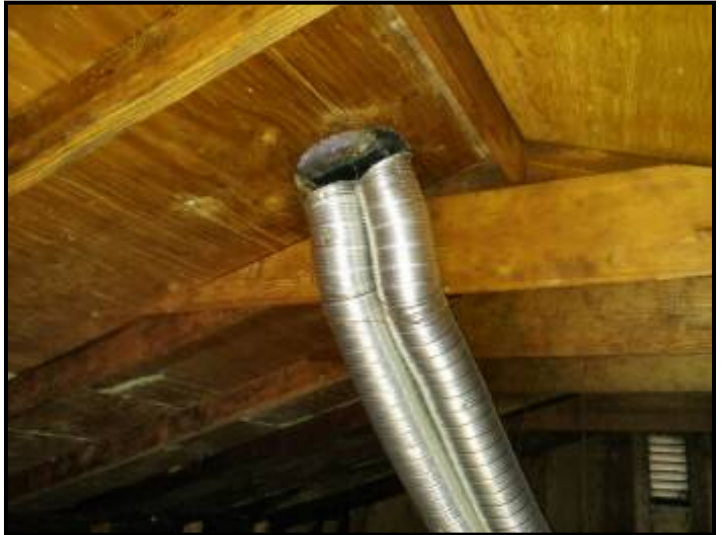
Upper bathroom vents vent toward a roof vent. A positive connection would be preferable.

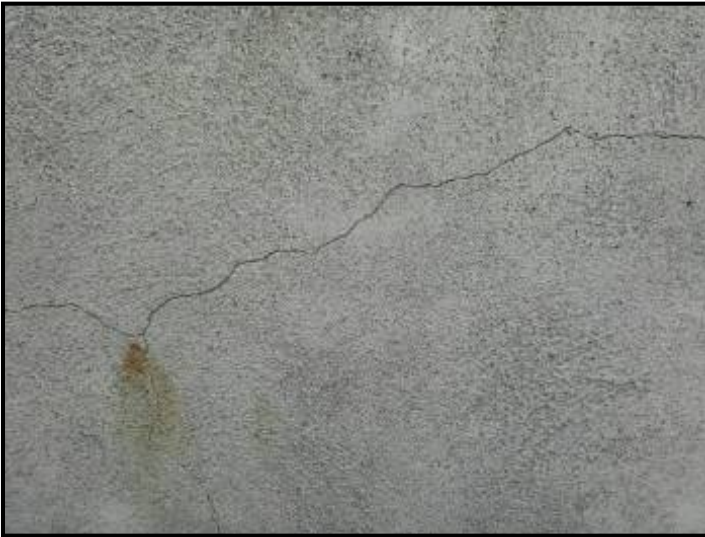
- Poured Concrete
- Cracks or Holes 1/4" or less present in: foundation. Recommend sealing them to prevent water infiltration. Generally speaking, cracks that are less than 1/4" are not commonly regarded as being structurally significant.
- Efflorescence visible on concrete, suggesting moisture penetration. Recommend hiring a licensed water mitigation specialist to inspect further.
- Visible portions of foundation wall were dry at the time of the inspection.

Foundation cracks observed

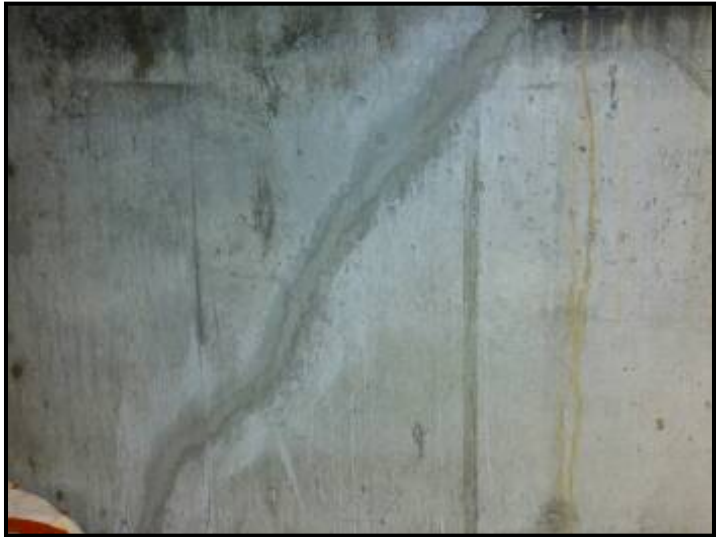
Foundation crack repair

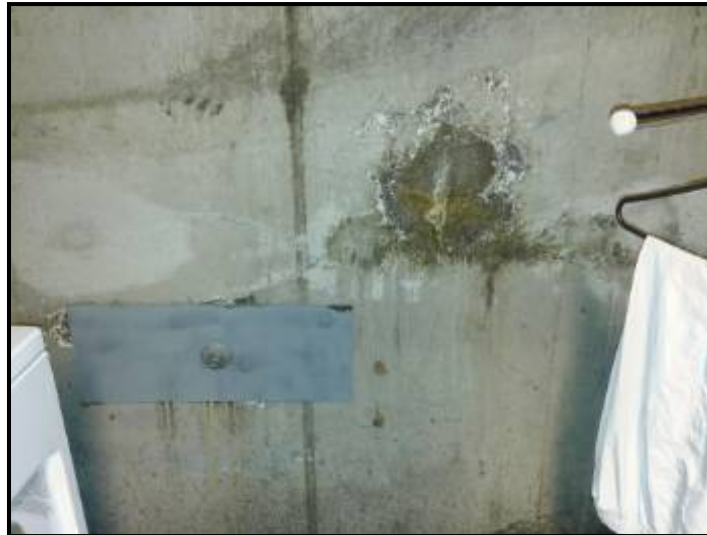
Horizontal crack in foundation was resupported. Repair appears to be done correctly

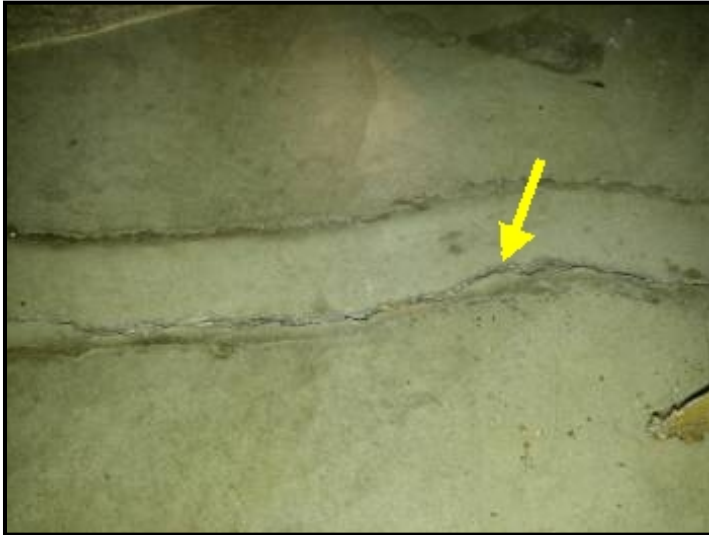
- A notable crack was observed on the basement floor near the fireplace. The crack had been repaired in the past but has continued to grow. Recommend hiring a structural engineer to evaluate further in order to stop and repair cracking in floor.

Large crack in basement floor appears to be recent. Repair made previously.

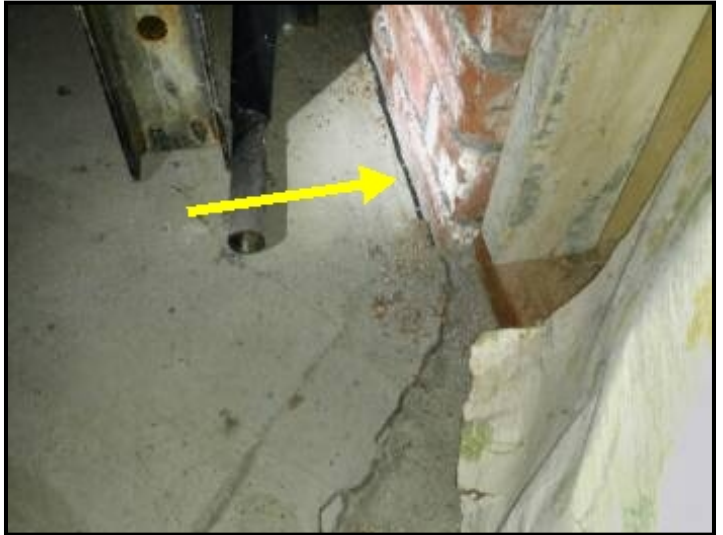
Cement slab is separating from chimney bricks

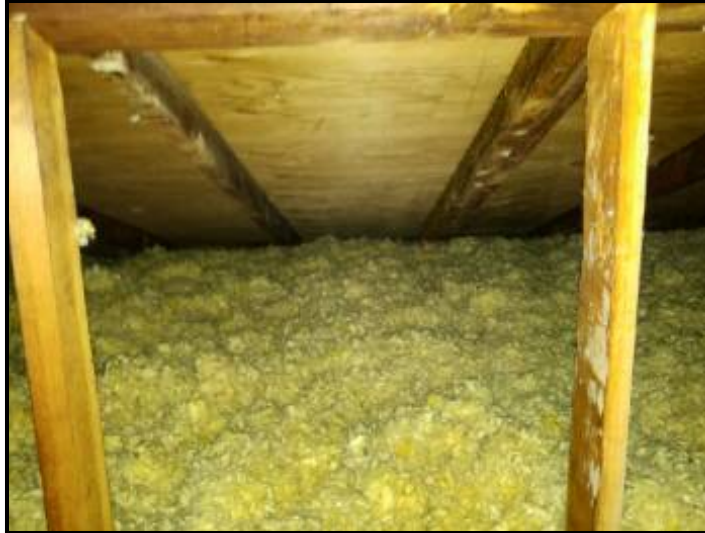
Loose fill blown in fiberglass. Ventilation baffles not installed
