Octopus Home Inspections, LLC

Your Property Inspection Report

8888 SE Example St, Portland, OR
Inspection prepared for: Example Report
Date of Inspection: 5/19/2015 Time: 12:00
Age of Home: 1971 Size: 1700
Weather: overcast

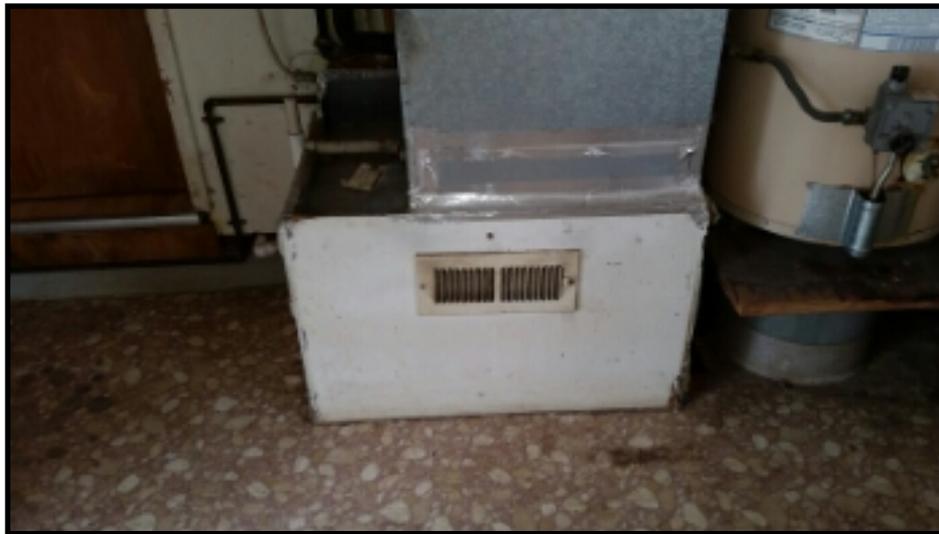
Plenum below furnace made of wood. This is not advised. recommend replacement with sheet metal by an HVAC technician

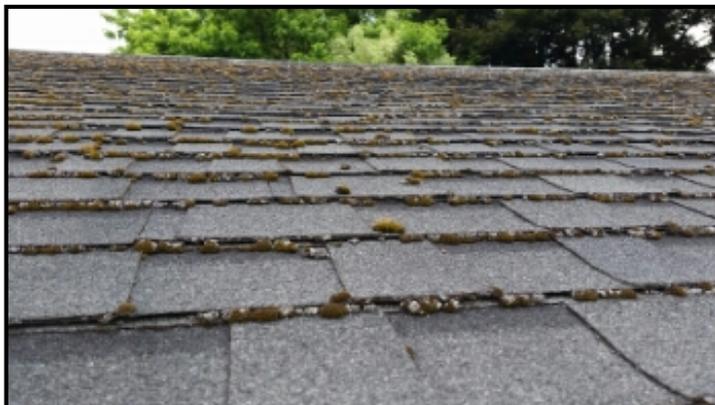
Moss on roof. This can lead to the premature failure of the roof and subsequent leaks. Recommend treating moss during its growing season (wet months) with a moss killer.

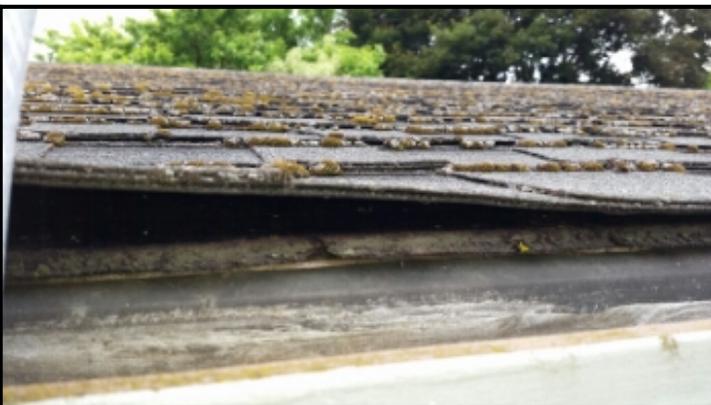
This roof appears to be 2 layers thick.

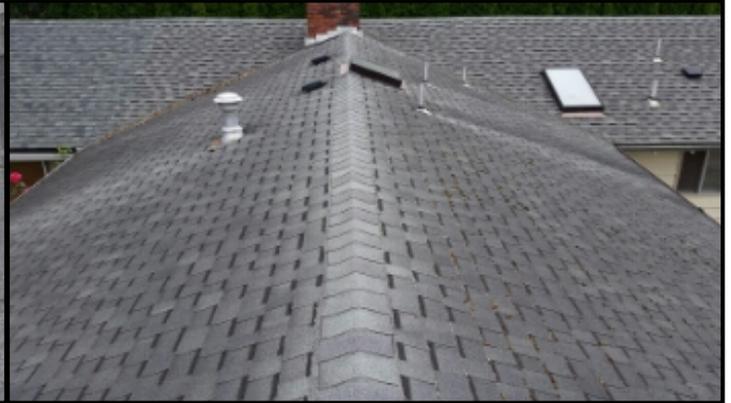
Roof covering appears in good serviceable condition.

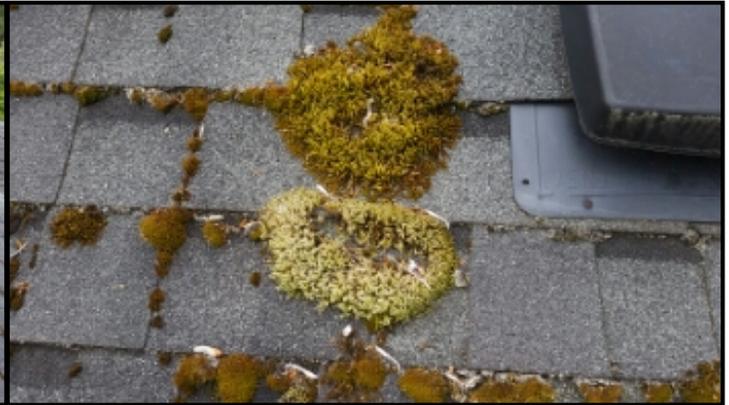
Moss on roof. This can lead to the premature failure of the roof and subsequent leaks. Recommend treating moss during its growing season (wet months) with a moss killer.

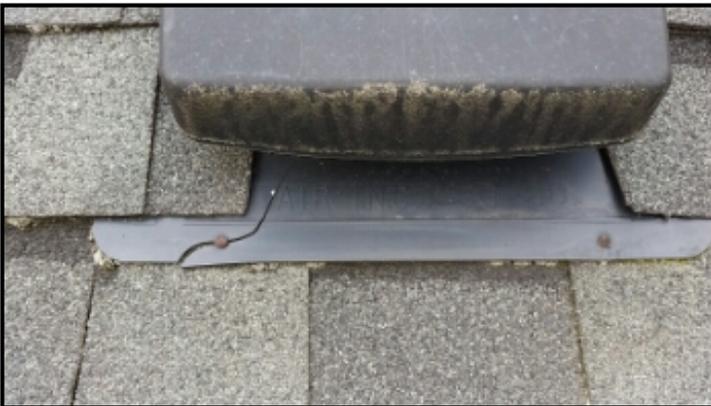
Roof vent(s) damaged. Recommend replacement by a licensed contractor.

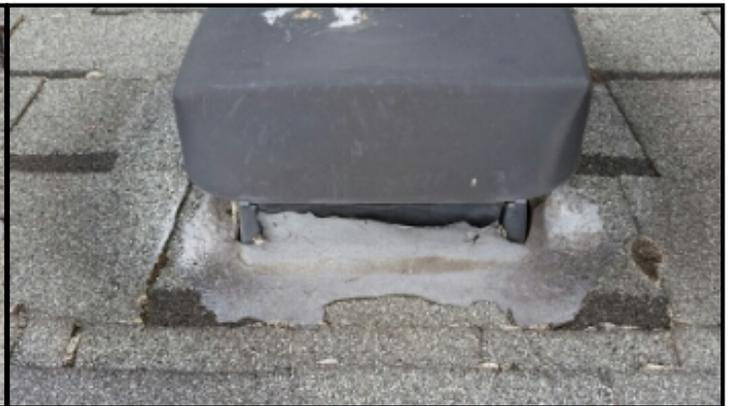
This roof vent appears to have been sealed post installation, but the sealant has failed. Recommend a licensed roofing contractor review further after it has rained.

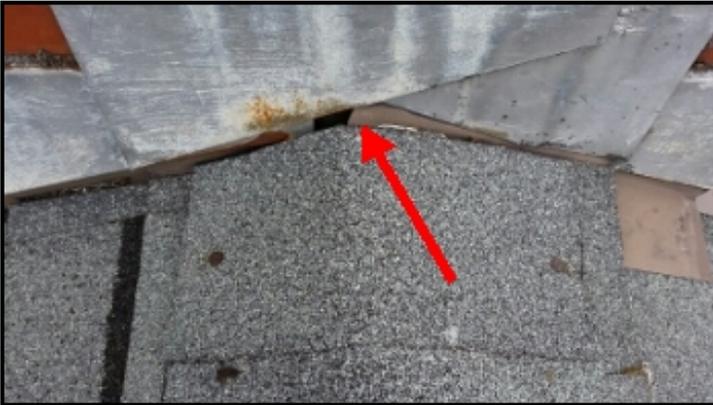
Questionable flashing at chimney. there appears to be a gap at the step flashing. Recommend having a licensed roofer inspect further after it has rained.

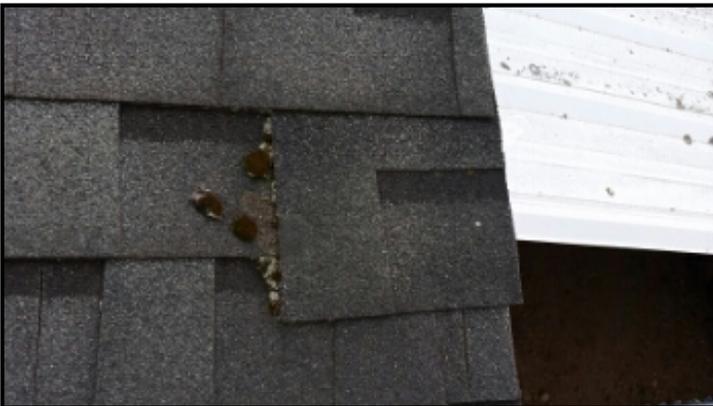
One roof shingle loose. Recommend having a roofer repair.

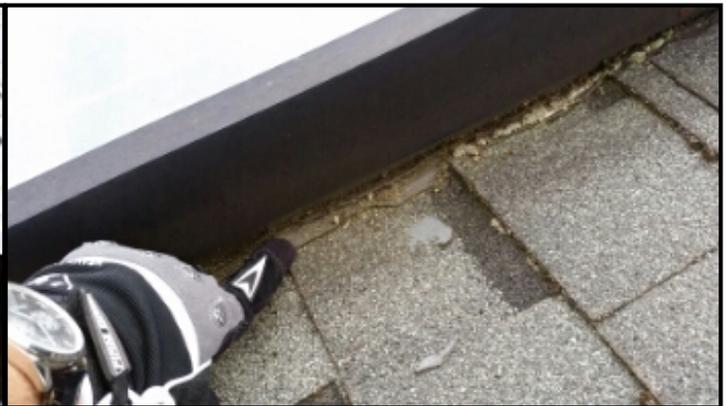
Step flashing at sky light appears to have been sealed. Recommend further inspection after a rain.

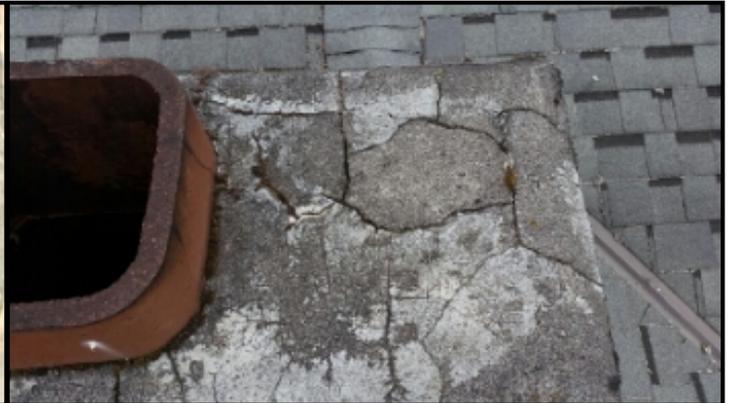
Chimney cap is failing. Recommend having a chimney expert review and repair if necessary.

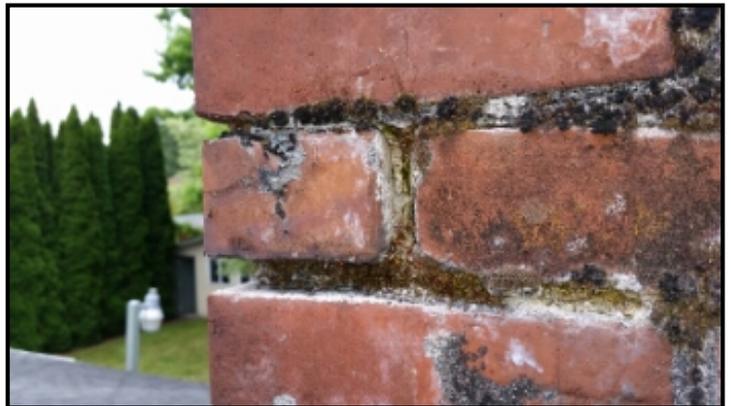
Chimney Mortar shows sign of deterioration. Recommend having repaired as necessary.

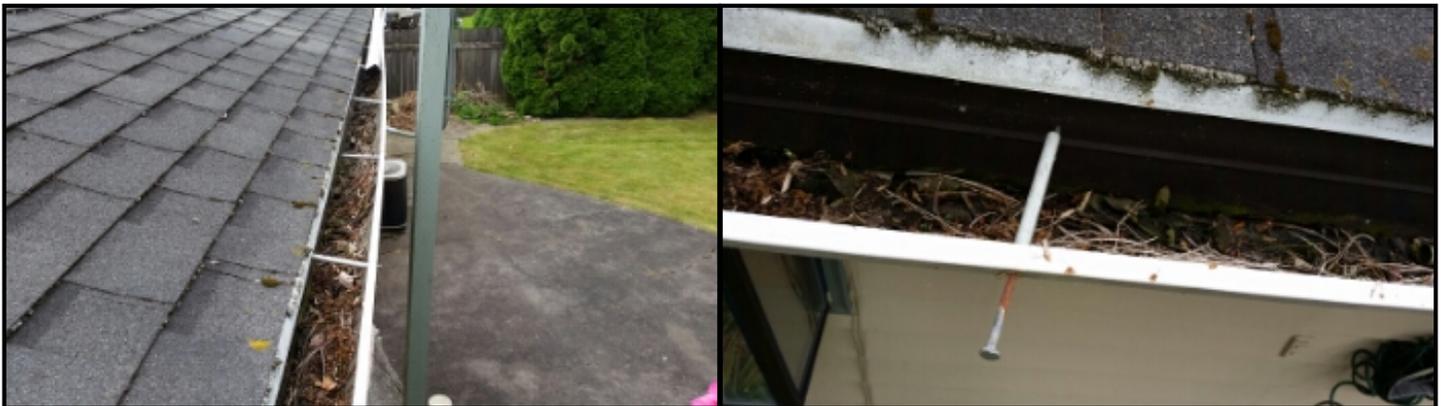
Gutter fasteners have pulled out of rafter tails.
Recommend having them re-secured.

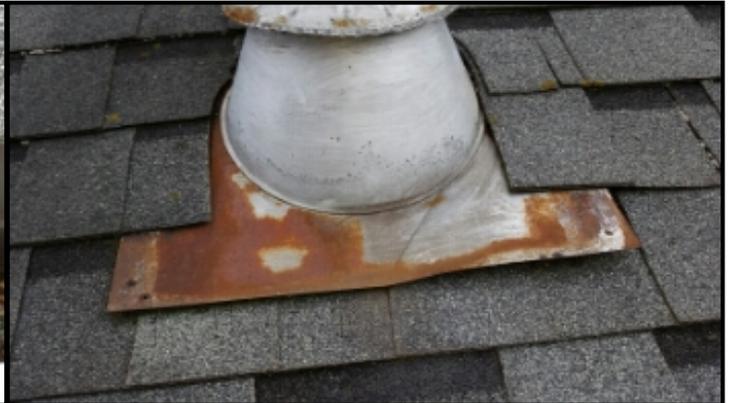
Apron flashing at roof vent peeling up. Recommend having a roofer inspect and repair if necessary.

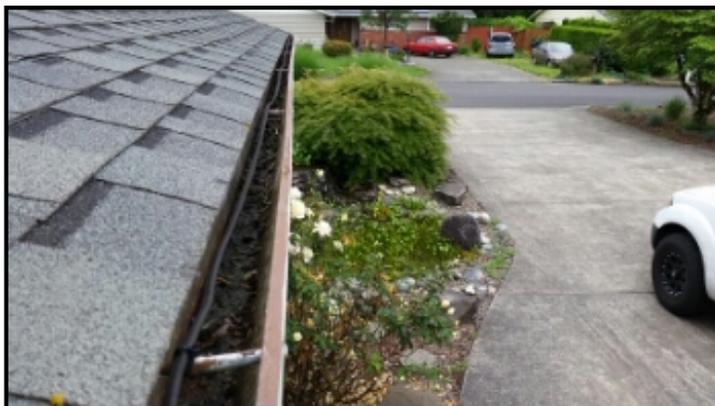
Gutter was used to run a coaxial cable. this adds additional strain to the gutter. recommend having the wires run in an alternate location.

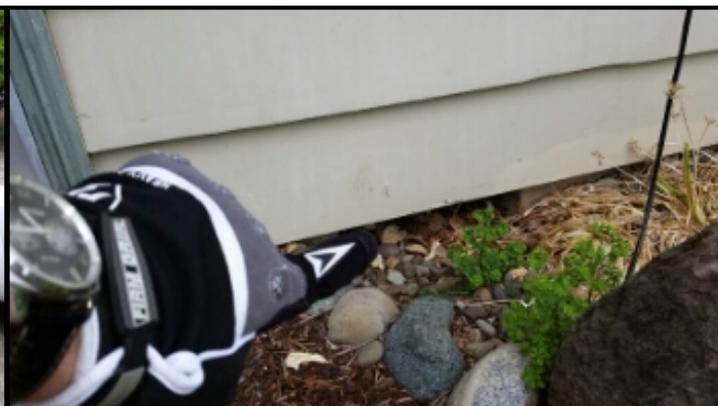
One or more foundation vents below grade. Recommend pulling dirt back so water doesn't access crawlspace

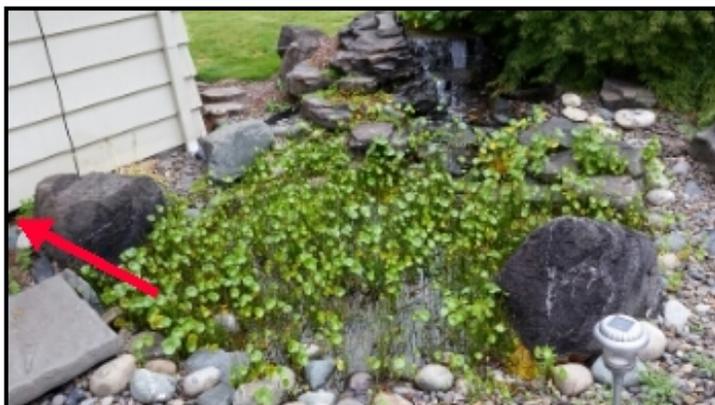
Water feature very close to the house. monitor water levels as to not allow it to overflow into the foundation vents (foundation vent marked with an arrow)

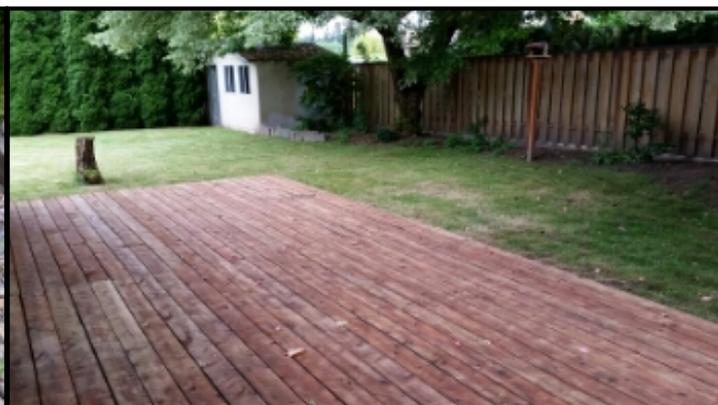
Rear of lot appears level, but bordering lot line is higher. Monitor lot line for water run off during rains.

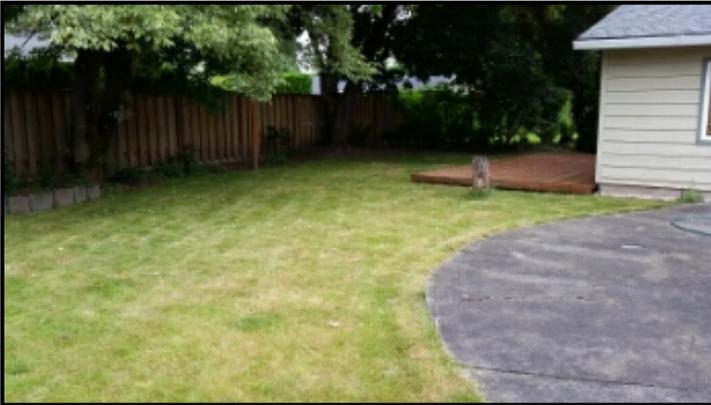
Grade appears flat, but lot is lower than rear bordering lot. monitor for water flow toward foundation from adjacent lot.

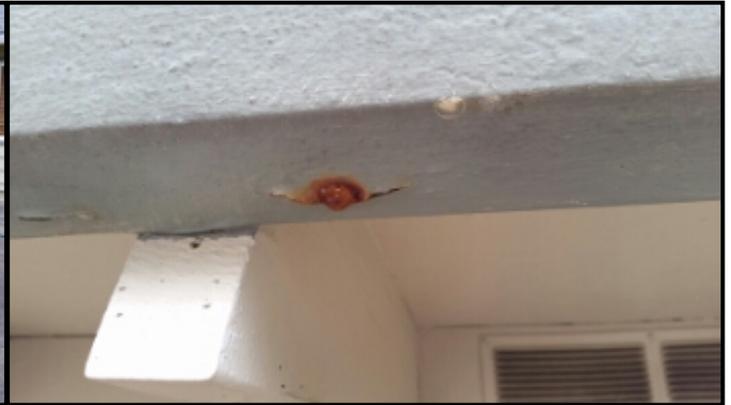
leak found in gutter above garage door

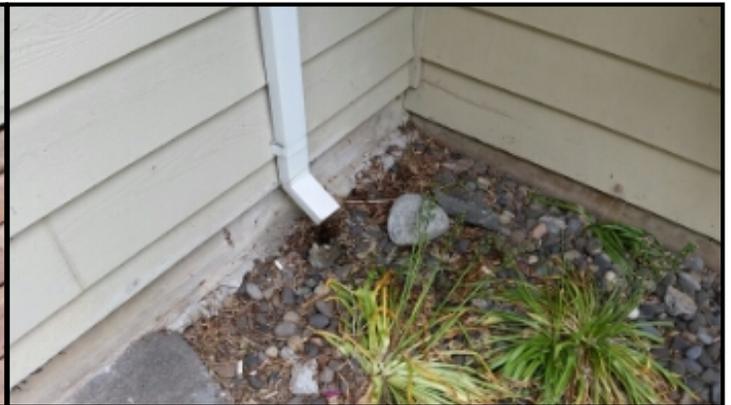
Extensions / Splash blocks missing or insufficient: Install to divert water away from the foundation.

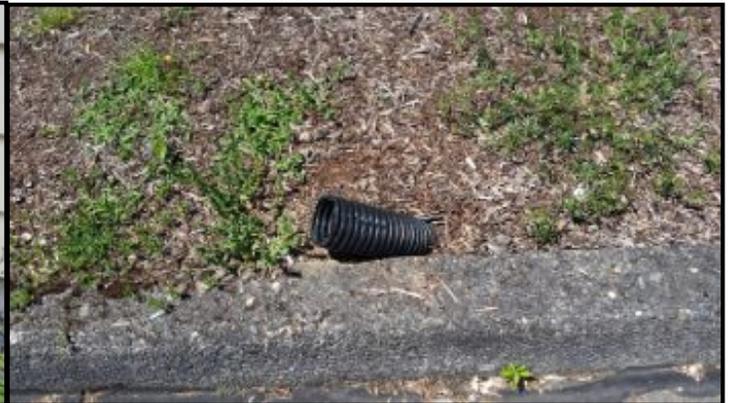
Corrugated pipe sticking out of ground. Verification of use recommended.

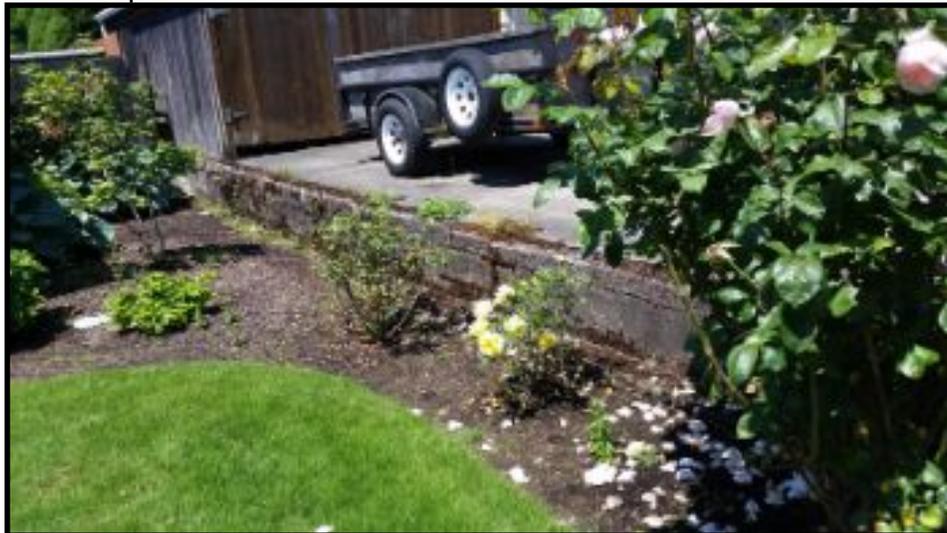
Retaining wall on south side of house. Recommend cleaning to elongate life.

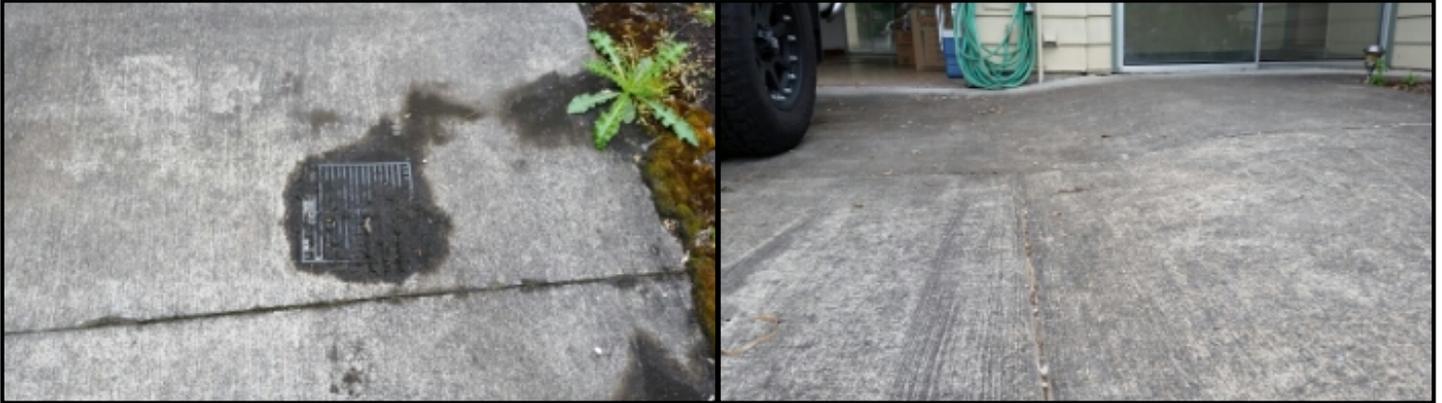
Driveway slopes toward house. drains have been installed, and some are plugged. recommend cleaning out drain and monitoring water mitigation.

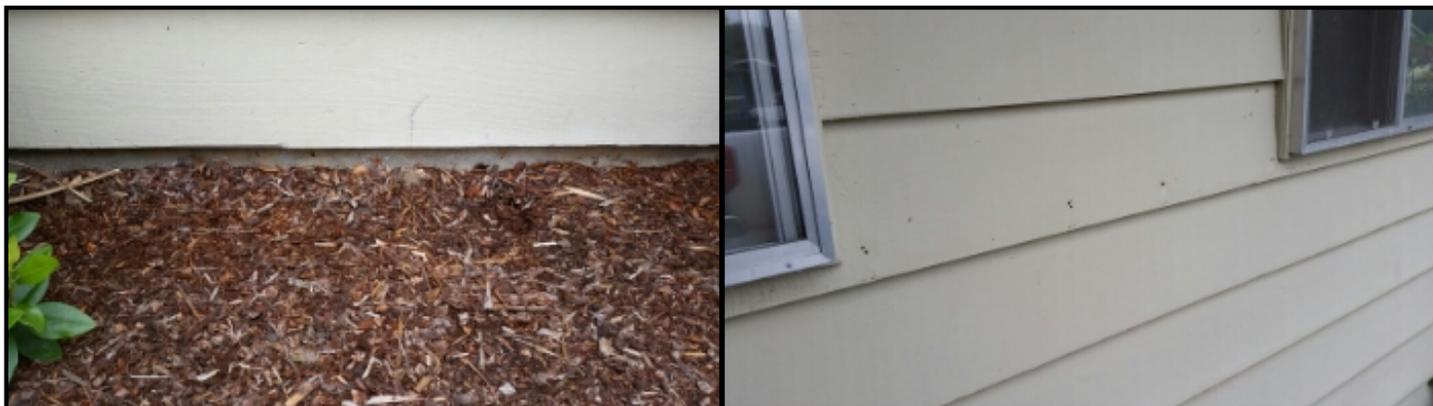
Siding-Soil contact or proximity. This may provide entrance of moisture or insects to siding. Recommend grading soil so there is at least 6" of space (where practical) between the siding and the soil below and checking for any damaged trim and siding materials.

holes drilled in siding between bathroom windows. recommend patching and painting.

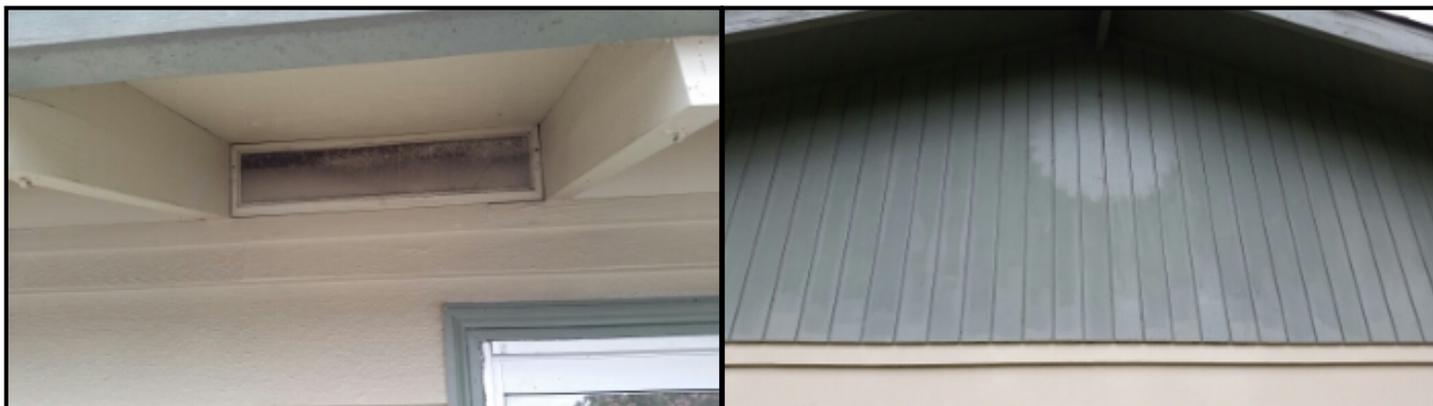
Eave vents blocked with insulation and paint overspray. recommend having insulation baffles installed and replacing the screens

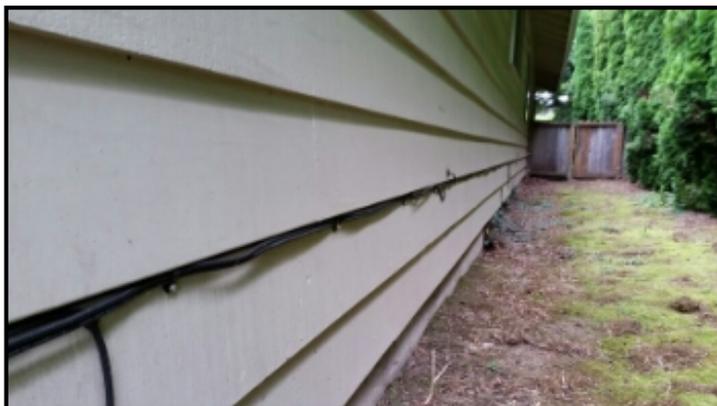
Wood lap siding. Good Condition.

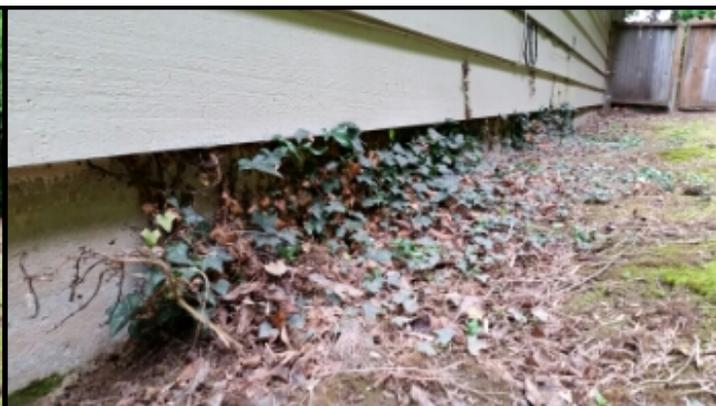
Ivy growing up foundation behind siding. Recommend removing ivy from foundation and monitor for reoccurrence. This is an invasive species.

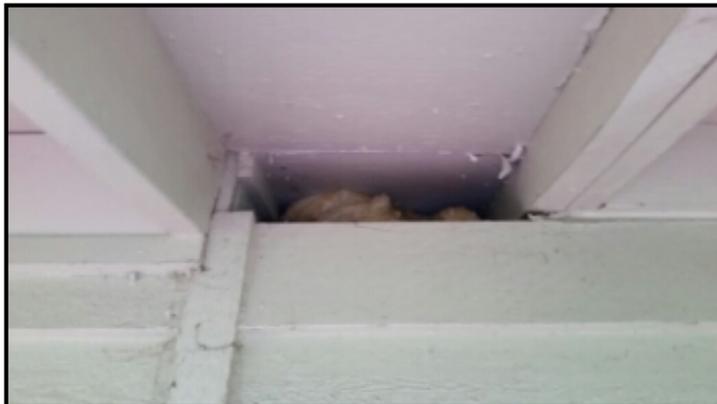
Soffit vent cover missing. Recommend replacement to avoid pests.

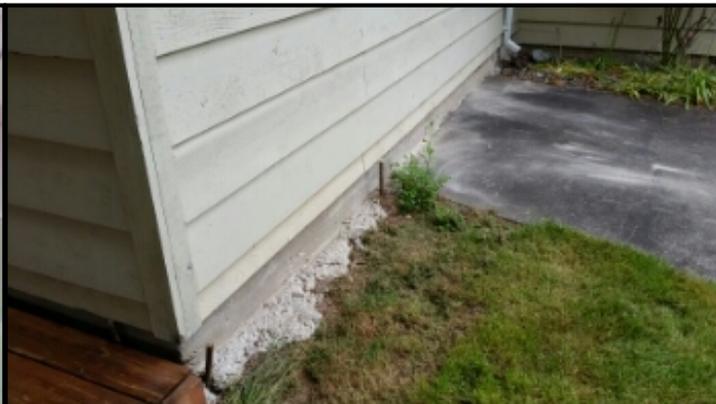
Addition in 2006 (per homeowner) is on a slab. Form holders never removed. this could be a trip hazard. Recommend removal.

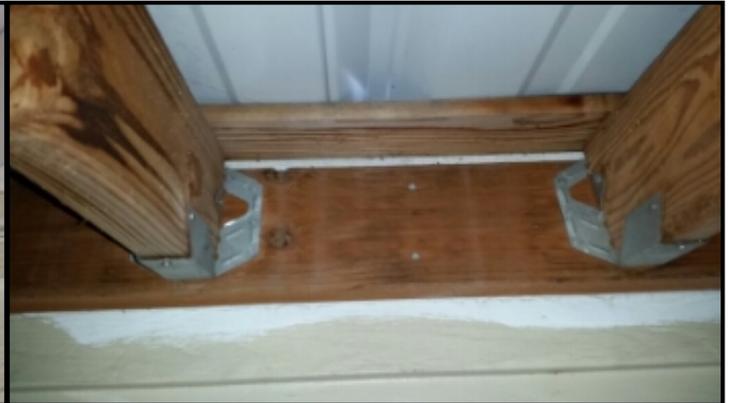
Shed roof attached to siding using framing nails. Recommend adding lag bolts for better dependability.

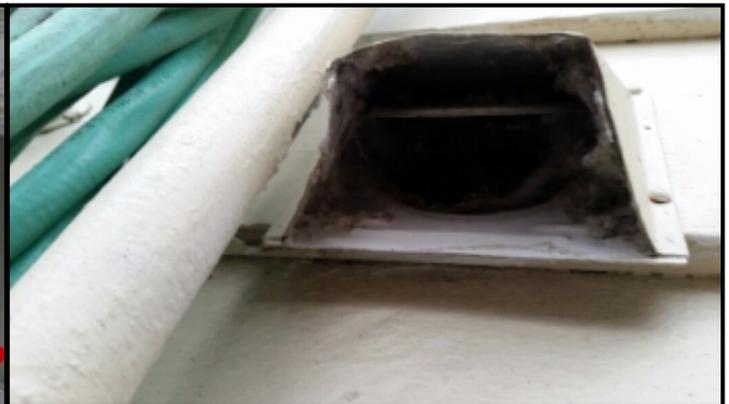
Dryer vent stuck open with lint. recommend cleaning so it can close and avoid pest intrusion.

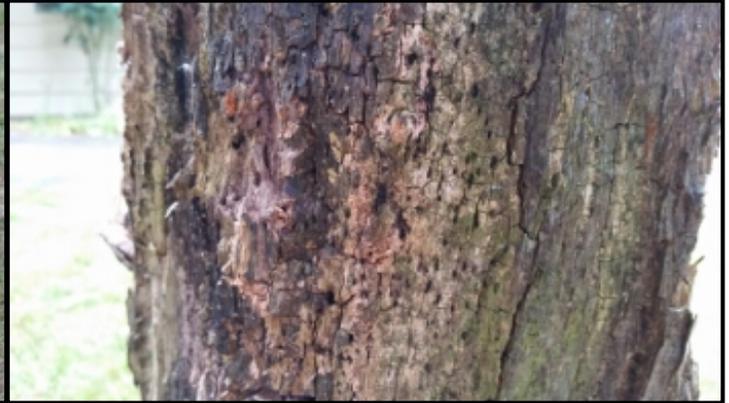
Possible exit holes in wood stump in back yard. Recommend removal.

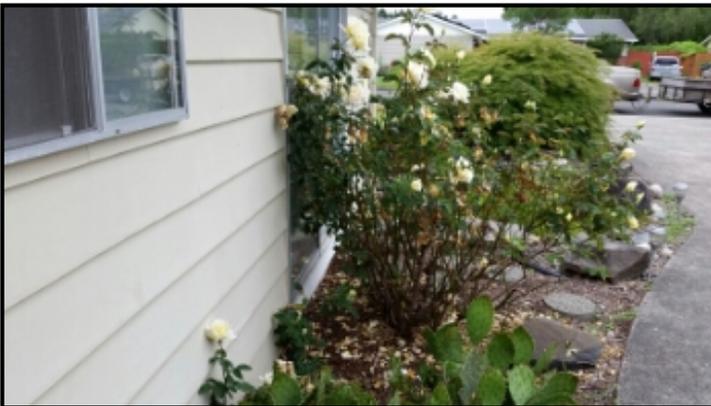
Vegetation in contact with siding which doesn't allow for siding to dry out after a rain. Recommend trimming or removal to leave a 12 inch gap between vegetation and siding.

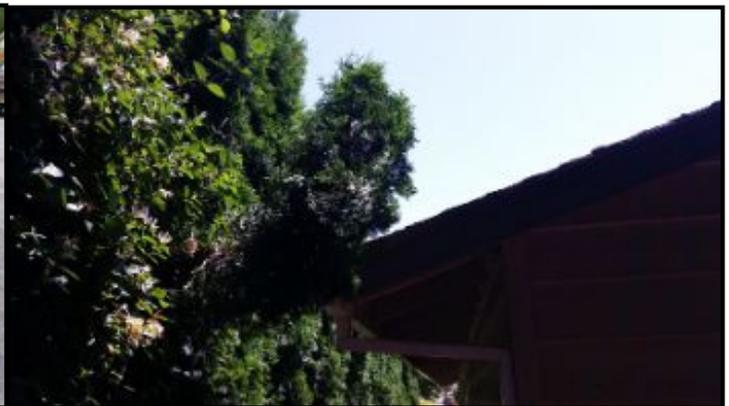
Arborvitae in contact with house. Recommend removal of limb.

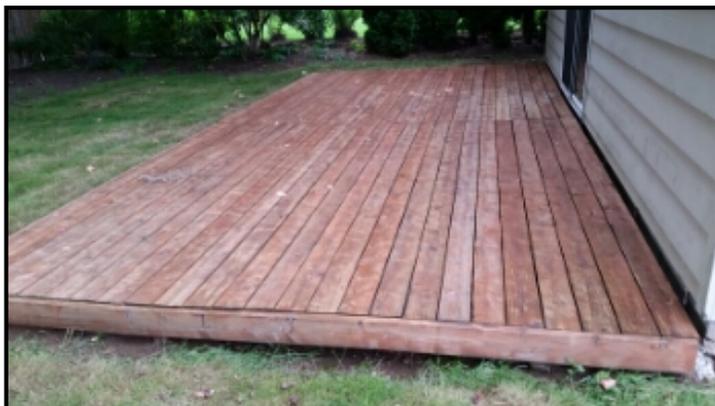
back deck is self supported and not in contact with house.

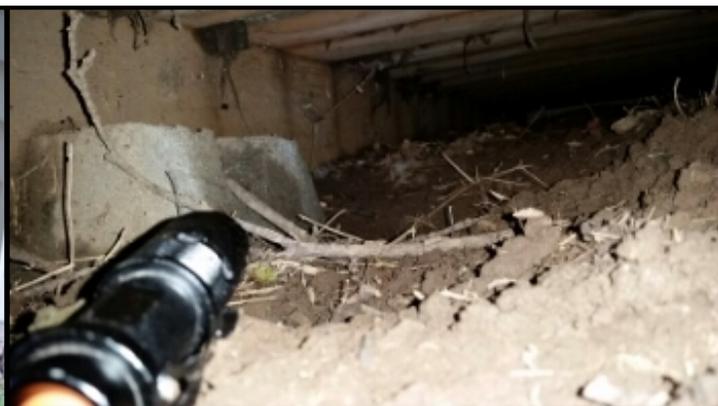
Wood – Soil Contact. This speeds up the decay process as well as entices wood destroying organisms (WDO) to enter your structure. Recommend pulling dirt away and inspecting further.

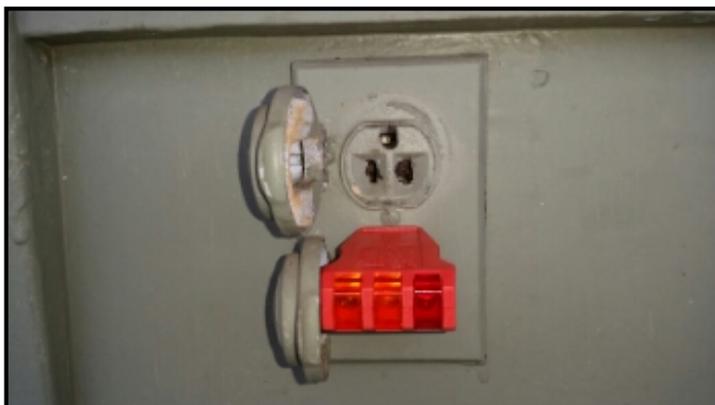
Electrical receptacle between garage doors is loose and wired incorrectly. Recommend having it repaired by a licensed electrician.

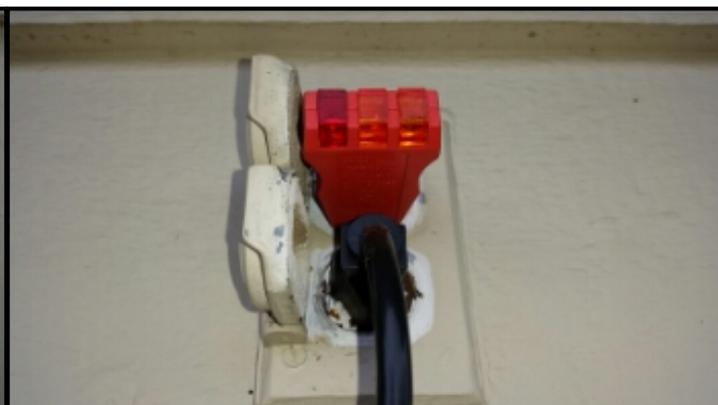
Hot-neutral reversed outlets present. This means that the black and white wires in the circuit have been reversed.

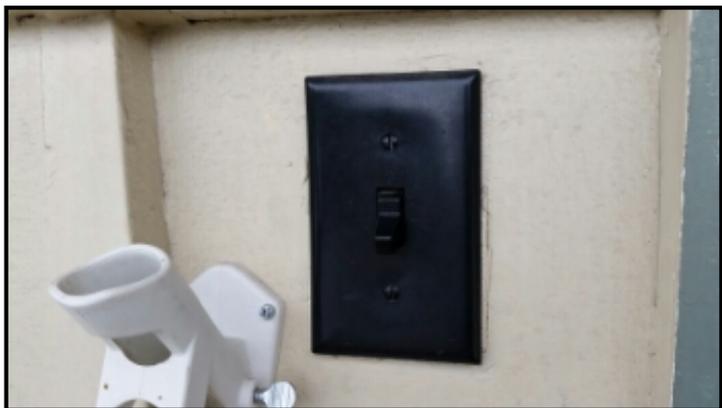
This is the switch for the front entry light. Switch cover not waterproof. Recommend repair by licensed electrician.

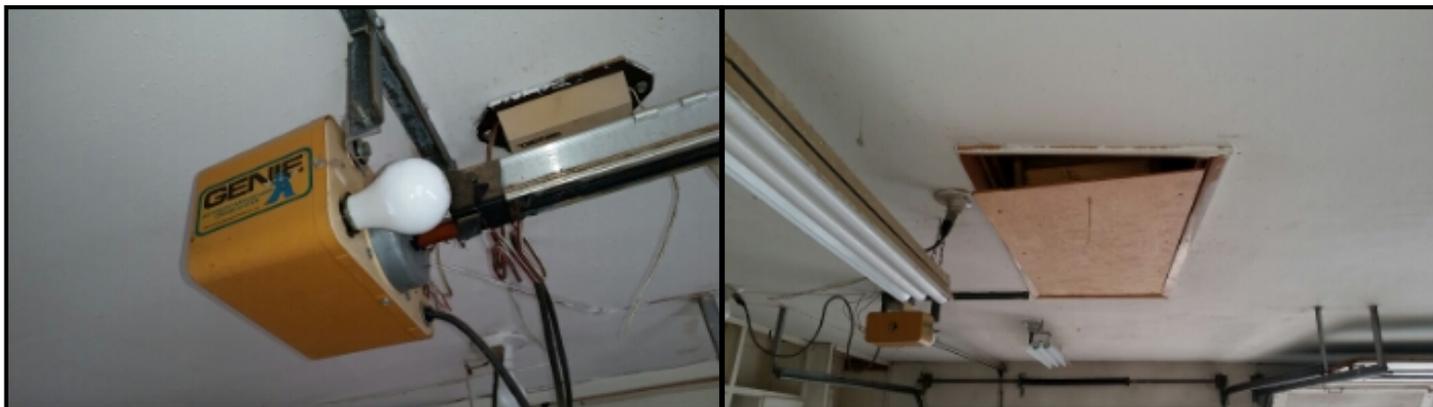
Garage door open failed reverse test. This is dangerous. Recommend replacement.

Drop down stair broken- Fire wall between garage & house not continuous. Recommend replacement.

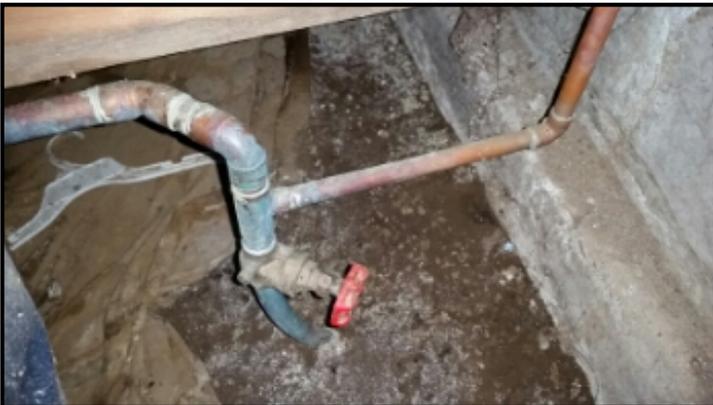
Main water shutoff found inside crawlspace access door in back closet.

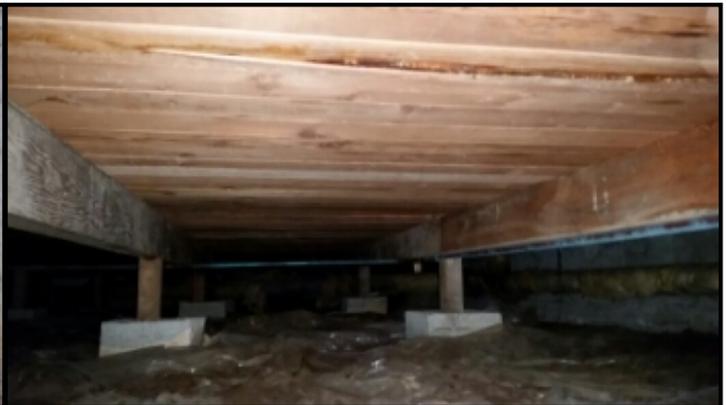
Post and beam construction. No floor insulation. Recommend insulating floor to avoid heat loss

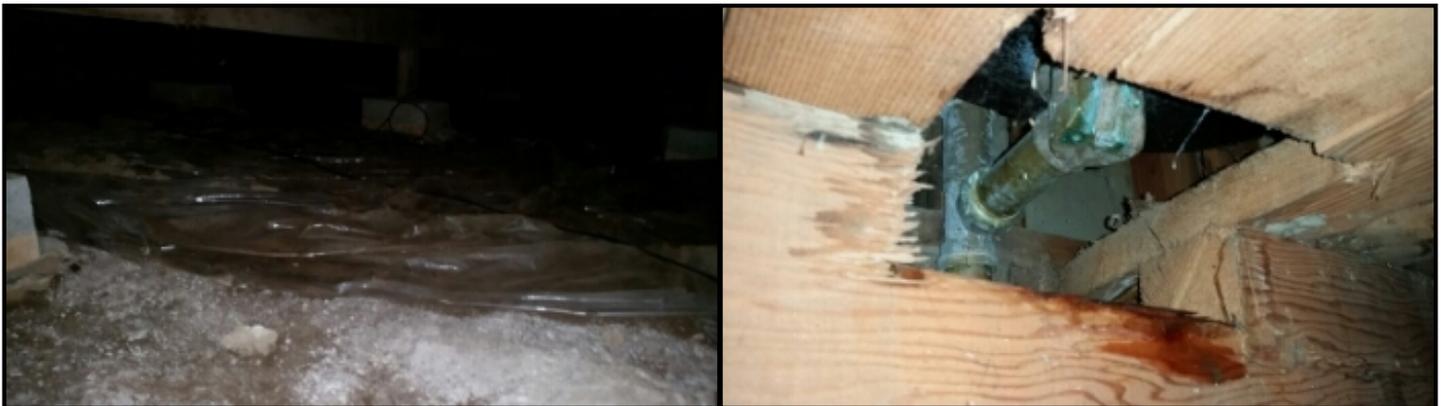
Vapor barrier incomplete. Recommend replacement

Bathtub leaks at drain. Recommend having this inspected and repaired by a licensed plumber.

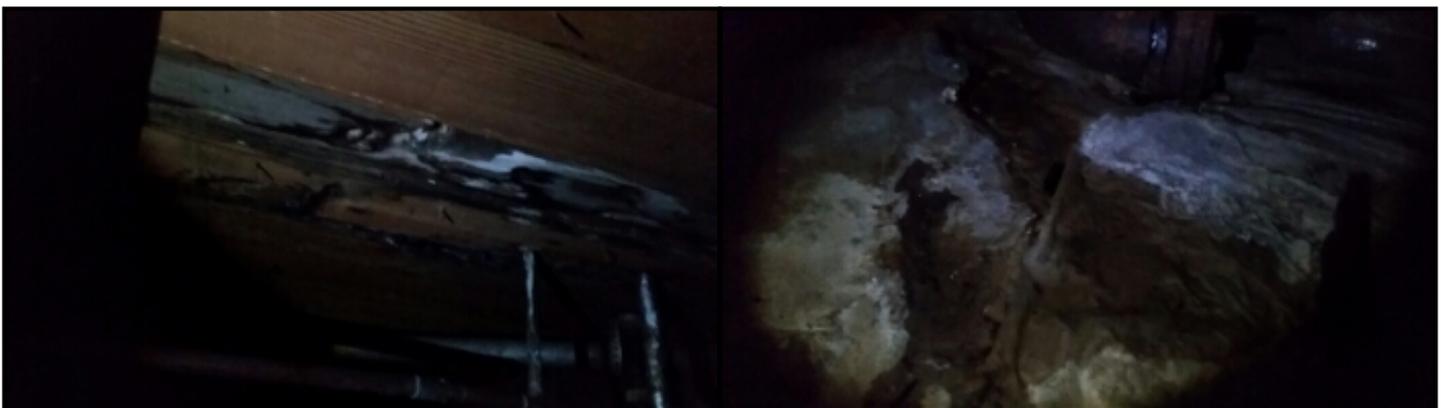
Signs of water leakage at master shower. Unclear if this is a current leak. recommend having plumber review further.

Dried water stains under master shower supply plumbing.

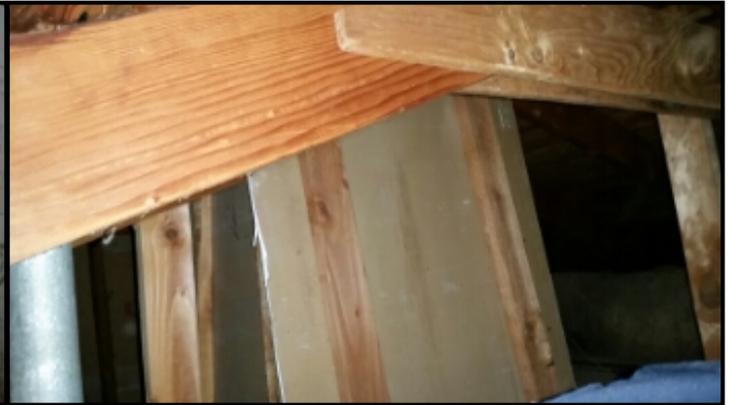
Sky lights are not insulated. this is a sizeable heat loss. Recommend having them insulated.

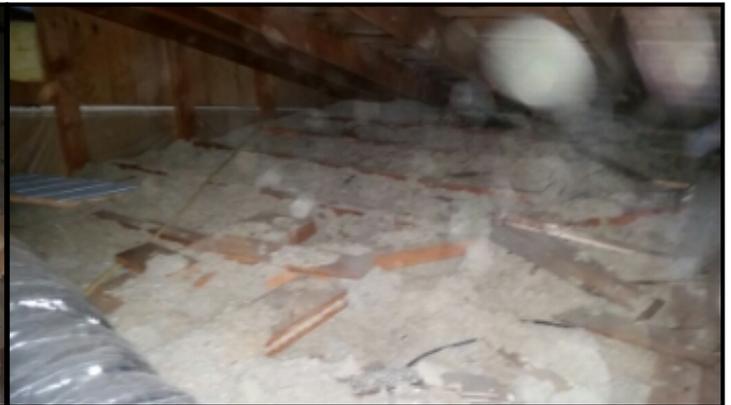
Insulation averages 3 to 4 inches. Recommend installing more.

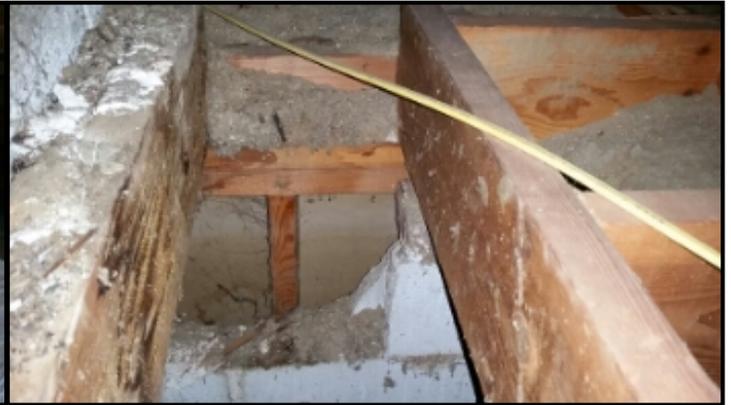
Brick and mortar missing at kitchen wall. recommend sealing to avoid heat loss.

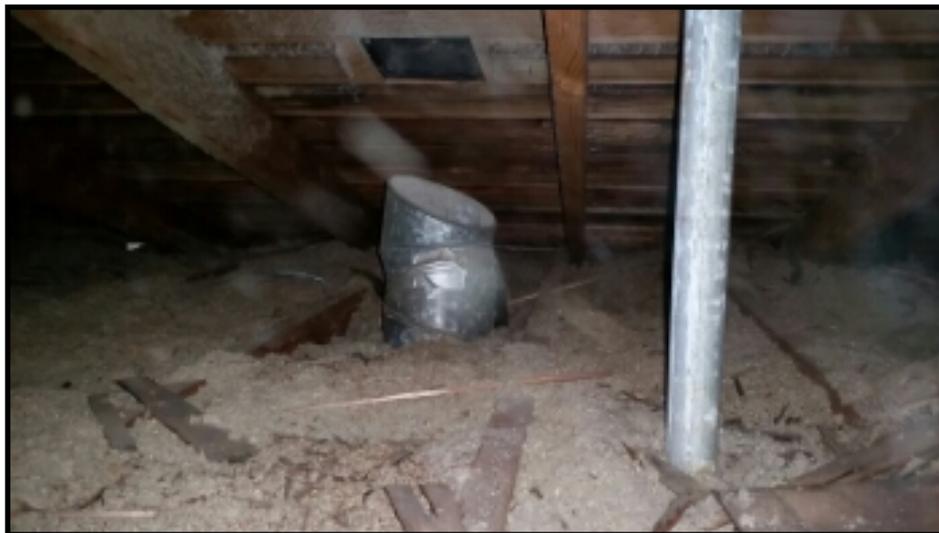
Master bathroom exhaust fan does not vent to exterior. Recommend having the duct run to vent outside attic space.

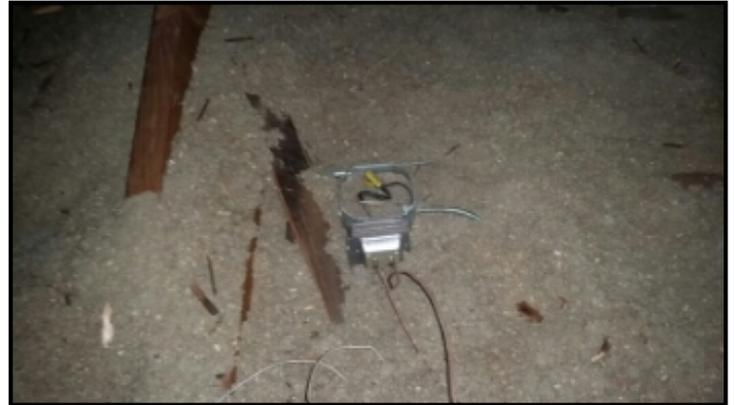
Open junction box in attic. Recommend having it covered by a professional electrician.

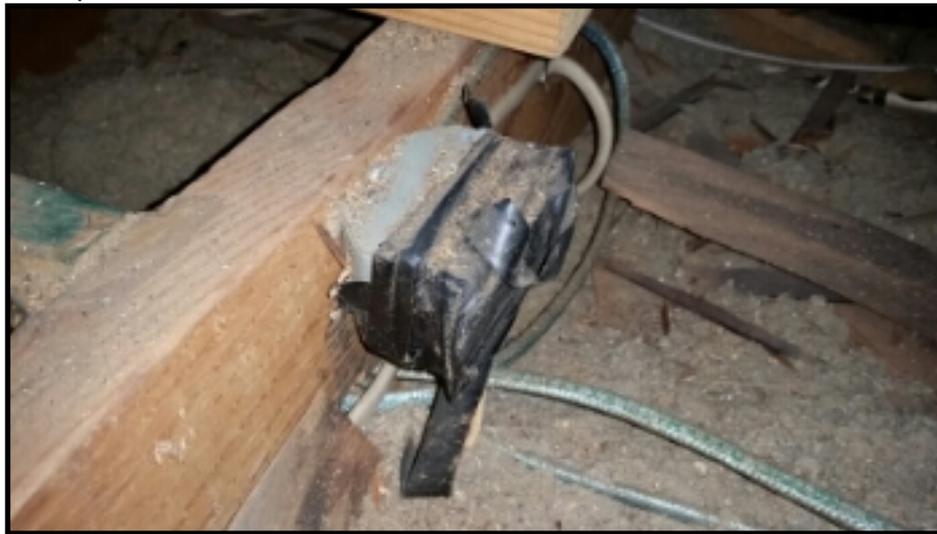
Improper cover over J box. Recommend having it repaired by electrician.

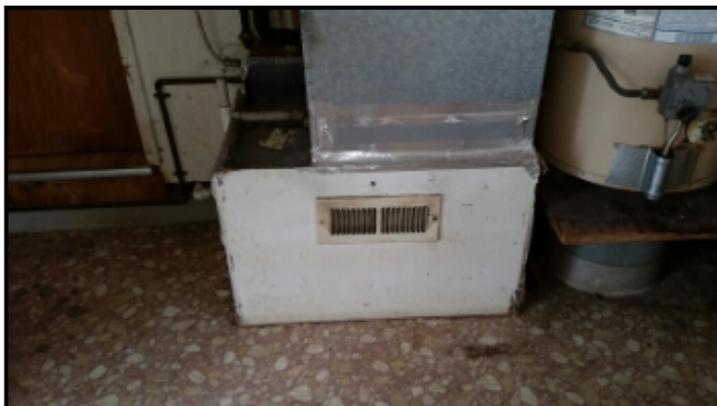
- **Furnace plenum in garage made of plywood. This is a danger due to the combustibility of wood. Recommend replacement by a qualified HVAC professional.**

Plenum below furnace made of wood. This is not advised. recommend replacement with sheet metal by an HVAC technician

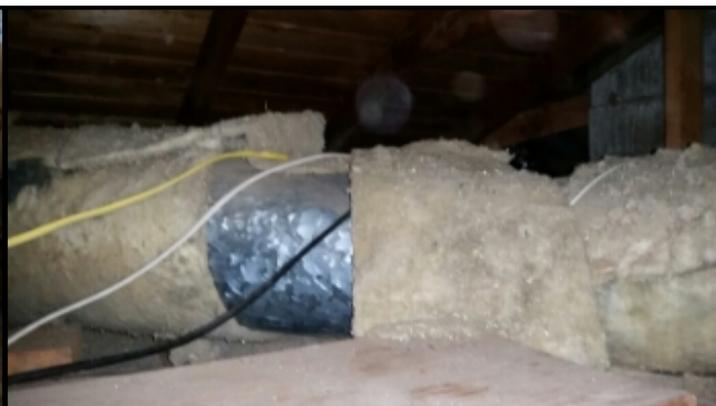
Warm air return found smushed. Recommend further review by an HVAC professional.

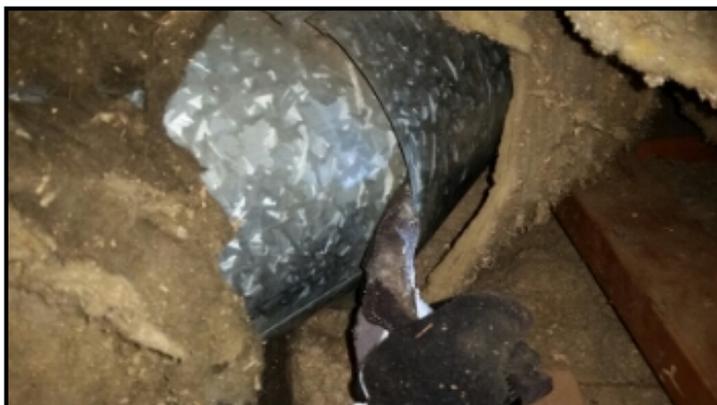
Warm Air return has sizable leaks. recommend having this inspected and repaired by an HVAC professional.

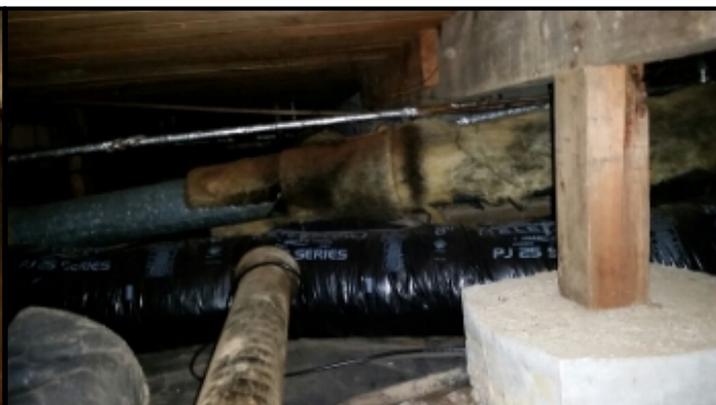
Soft duct laying on floor. Recommend suspending this duct from the floor joists for a longer lasting product.

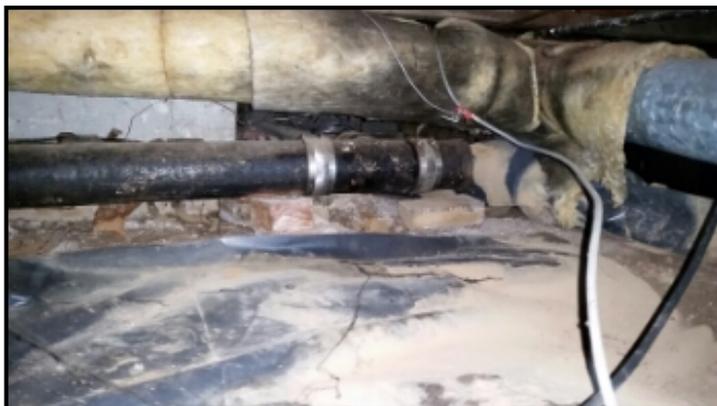
Signs of duct leakage. Recommend having your ducts tested and sealed.

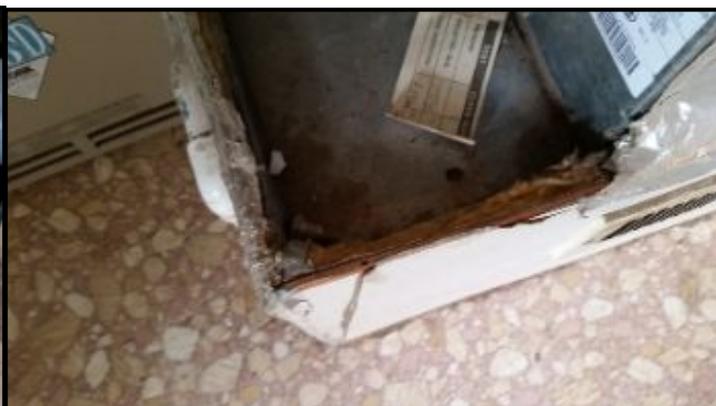
Bottom plenum at the furnace is made of wood. Recommend replacement by an HVAC professional.

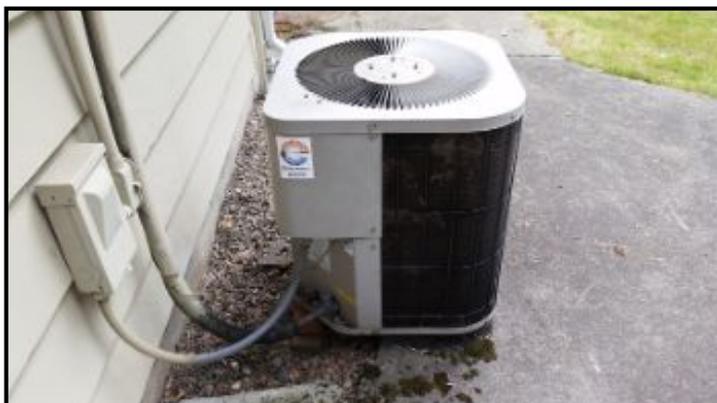
Air conditioner appears to be level, but it is not supported correctly. Only half of this unit is on solid ground. Recommend further inspection and support by a HVAC professional.

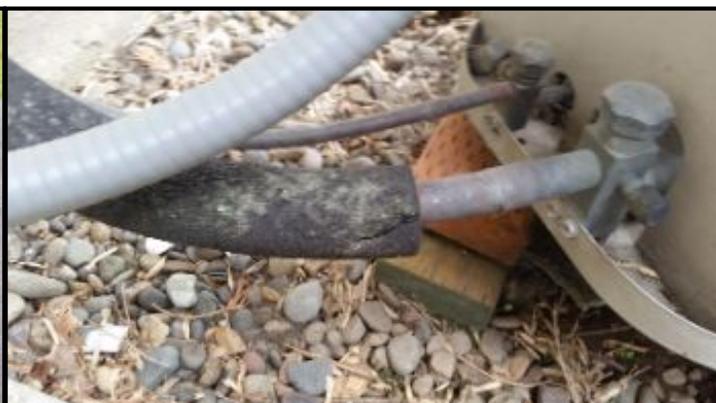
Condensate line (larger line) is not completely insulated. REcommend insulating to avoid rusting the exterior of the HVAC unit.

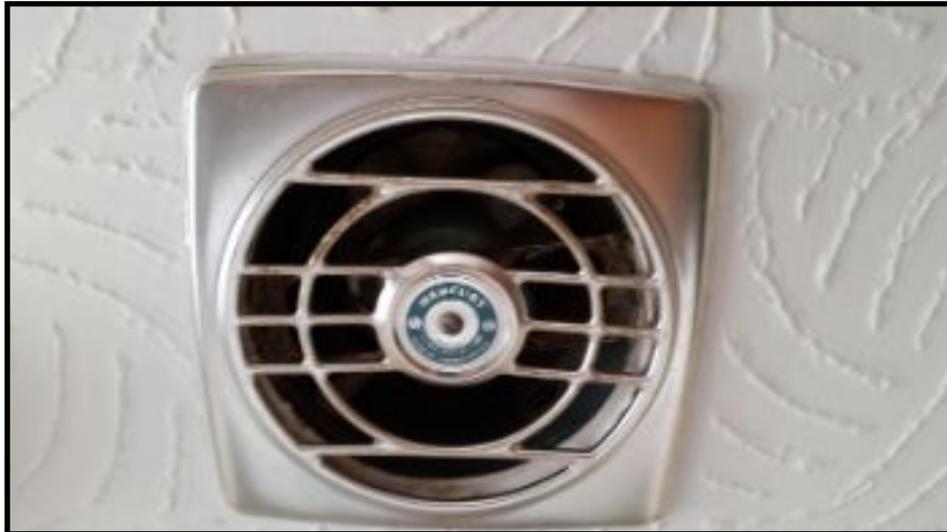
master bathroom exhaust fan is under powered. Recommend replacement.

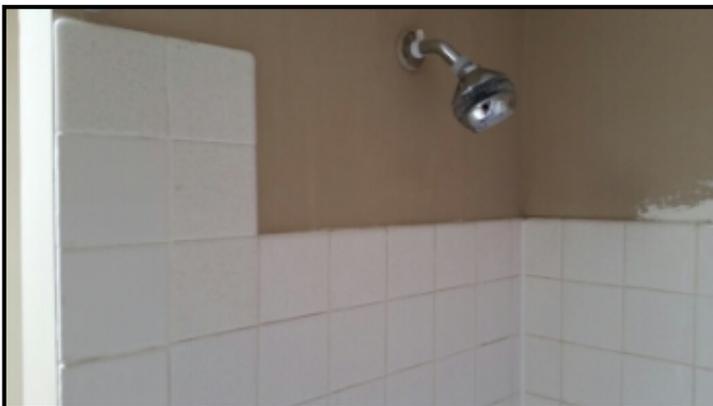
Bathtub splash guard is not at the recommended 6 feet in height. This could enable the walls to get wet and create a moisture issue. Recommend further review by a contractor.

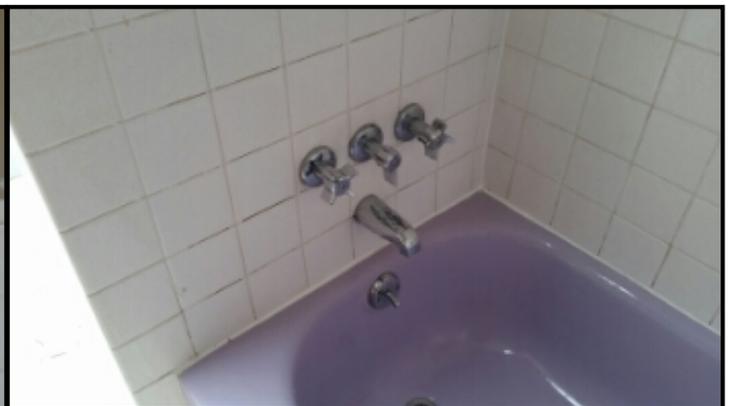
Bathtub drain does not hold water. Recommend replacement.
