Octopus Home Inspections, LLC

Your Property Inspection Report

8888 SE Example St, Portland, OR
Inspection prepared for: Example Report
Date of Inspection: 5/19/2015 Time: 12:00
Age of Home: 1971 Size: 1700
Weather: overcast

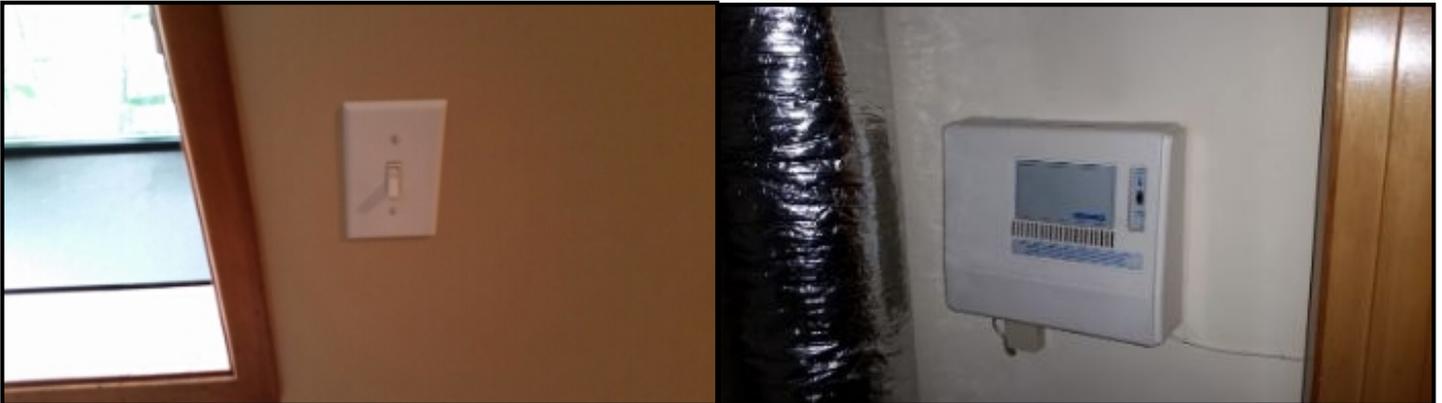
Switch purpose unknown. Check with seller. This is located next to the garden window.

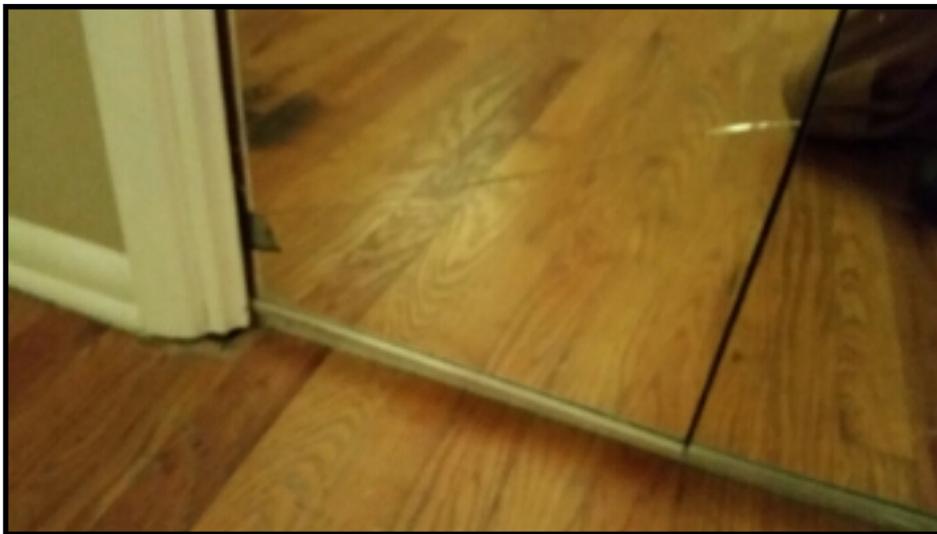
Accordion closet doors operate poorly and the glass is cracked at accordion closet doors. Recommend replacement.

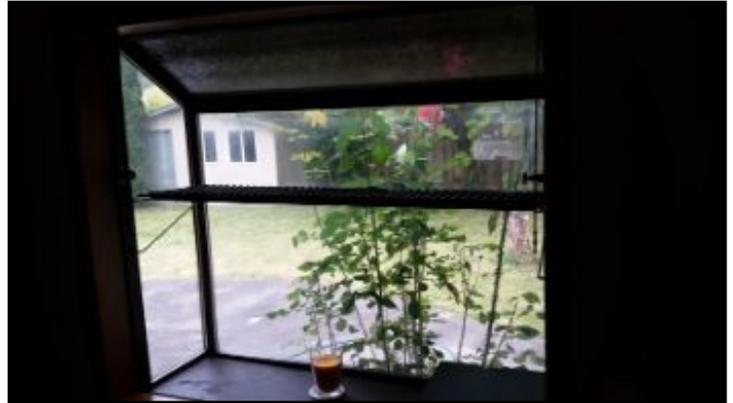
Duel glazed garden window in kitchen appears to have broken seals.

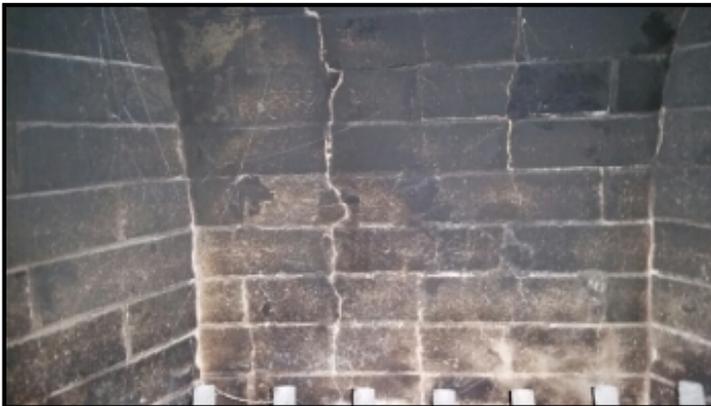
Fire bricks cracked/damaged; recommend evaluation by qualified technician.

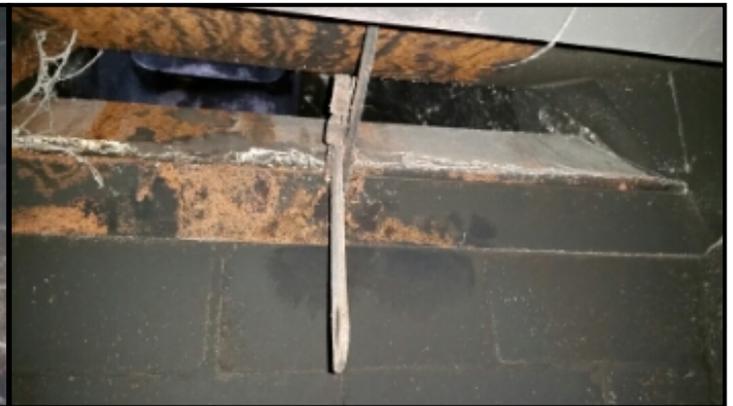
Damper hardware damaged. It is stuck in the open position. This is both an energy waste and an opening for pests. Recommend repair by licensed professional.
