Octopus Home Inspections, LLC

Your Property Inspection Report

7716 SW 26th Ave, Portland, OR 97219
Inspection prepared for: Don & Sherri New
Real Estate Agent: -

Date of Inspection: 6/8/2016 Time: 0:00 PM
Age of Home: 1966 Size: 2638
Weather: Sunny, Dry
Order ID: 89

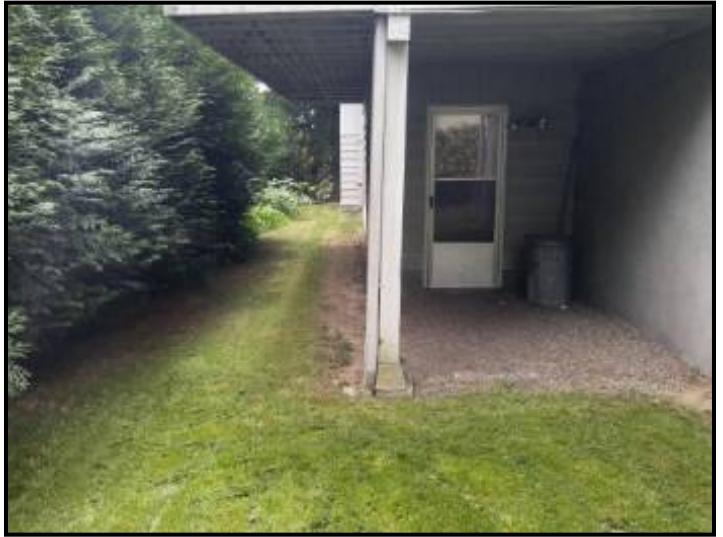
- Grading around house is uneven. Portions of the land surrounding the home are sloped toward the house channeling water towards the foundation when it rains.
- House is built on a slope. Attention should be kept to assure water is draining around the foundation. A french drain may be a good addition to usher surface drainage around the foundation.

Rear of lot slopes down and away

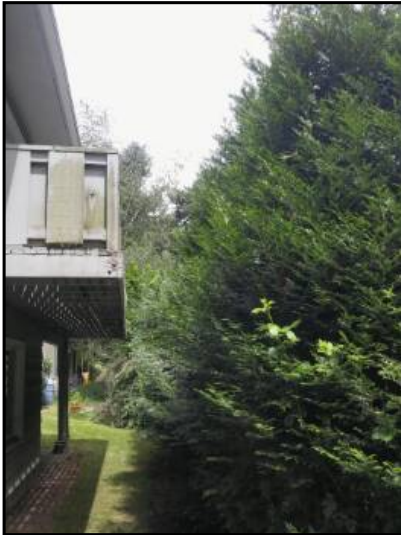
Rear tree growth is very close to house and wood deck.

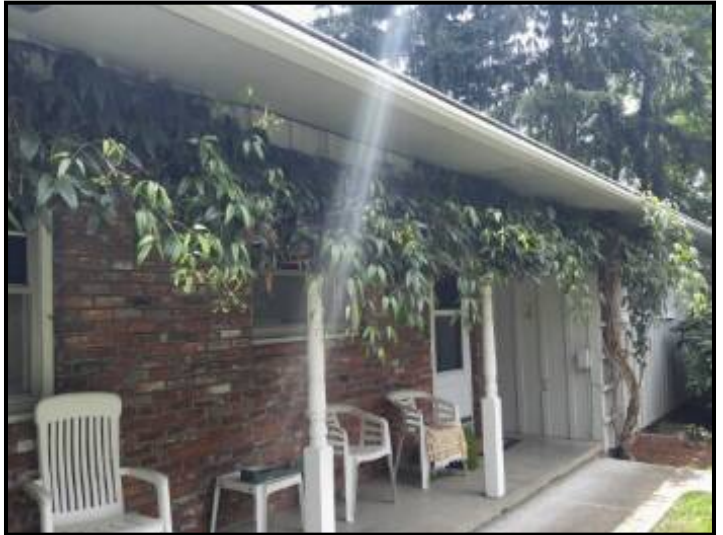
Clematis growing on house and into gutters

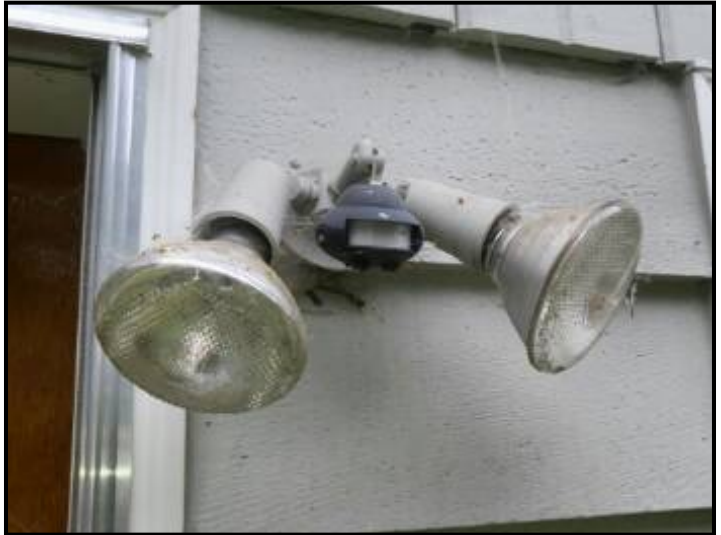
Some exterior lighting is on a sensor and could not be verified for operation

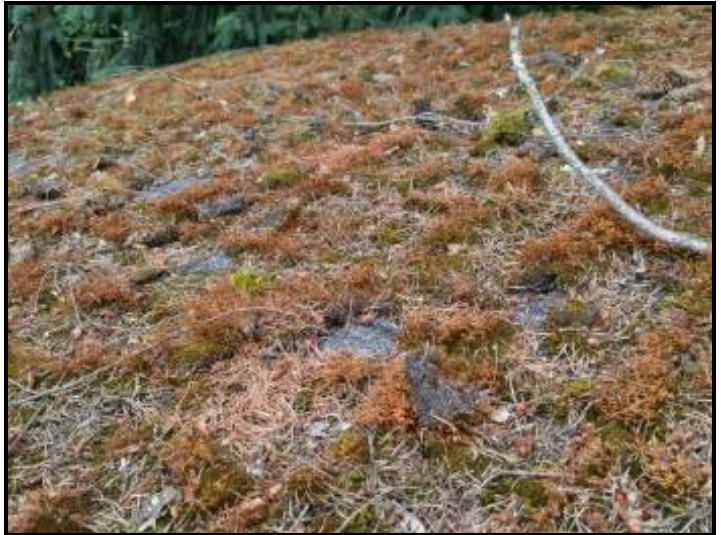
Large amount of organic debris on roof from adjacent trees to the south

Page 15 Item: 1	Roof Covering and Flashing Observations	<ul style="list-style-type: none">• Significant amounts of organic debris evident. Recommend cleaning roof covering to discourage moss growth and moisture retention.• One or more roof penetrations have been sealed with tar or mastic instead of conventional metal or plastic flashings. Leaks may develop over time as the sealant deteriorates. The penetrations will need to be diligently monitored for leaks and periodically re-sealed. Replacement of the flashing is a better alternative and is recommended.
-----------------	---	---

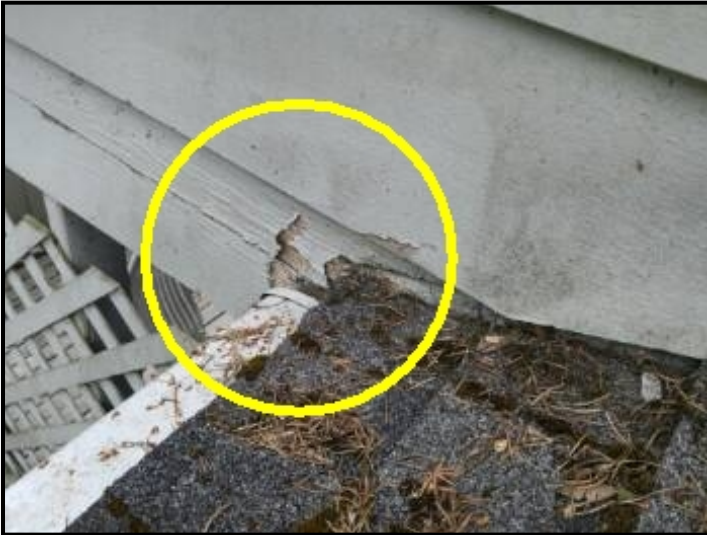
Exposed wood at gutters above deck

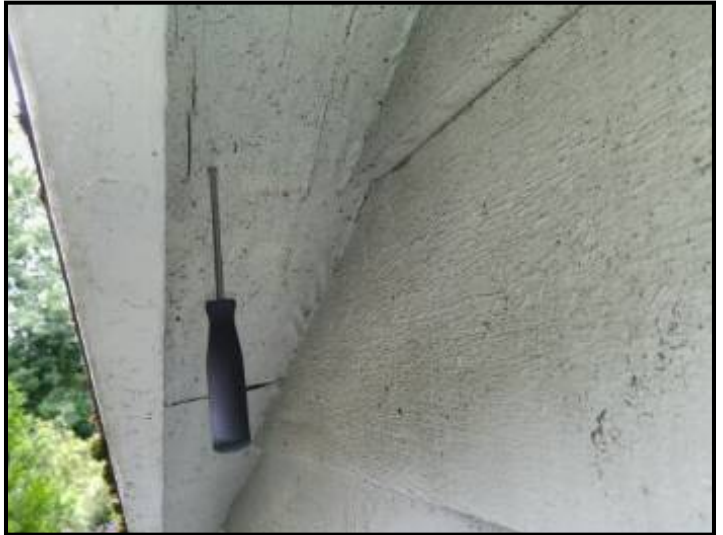
Roof decking is soft at edges under overhang

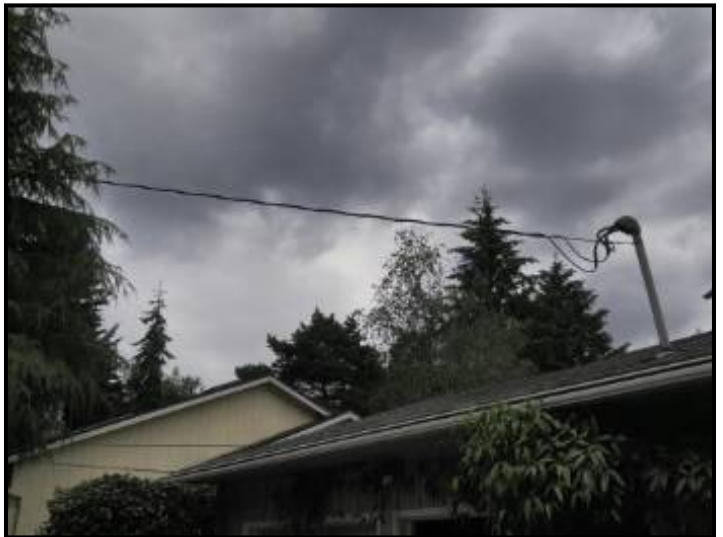
Electric service line has no slack.

Page 32 Item: 2	Service Entrance	<ul style="list-style-type: none">• Electrical service mast on roof is leaning or bent. The service lines coming to the house from the adjacent pole is taught. The inspector believes there has been a shift of some sort taking any slack in the high voltage line away and the result is the metal mast coming up from the house to receive the wires is now bending in order to hold the wires. Highly recommend having the power company out to review the situation soon.

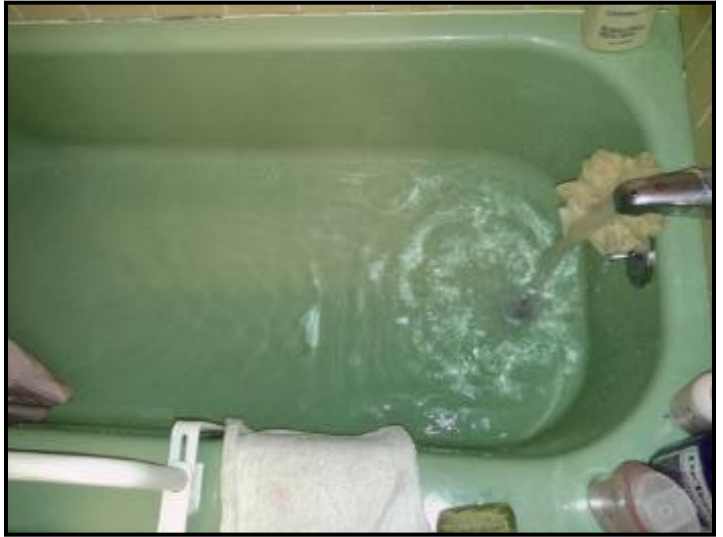
Bathtub drain cannot keep up with water supply

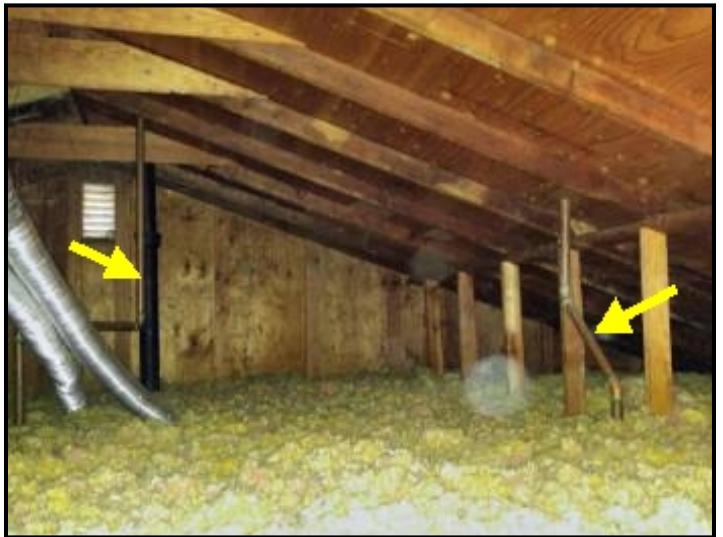
Copper venting pipes for plumbing system

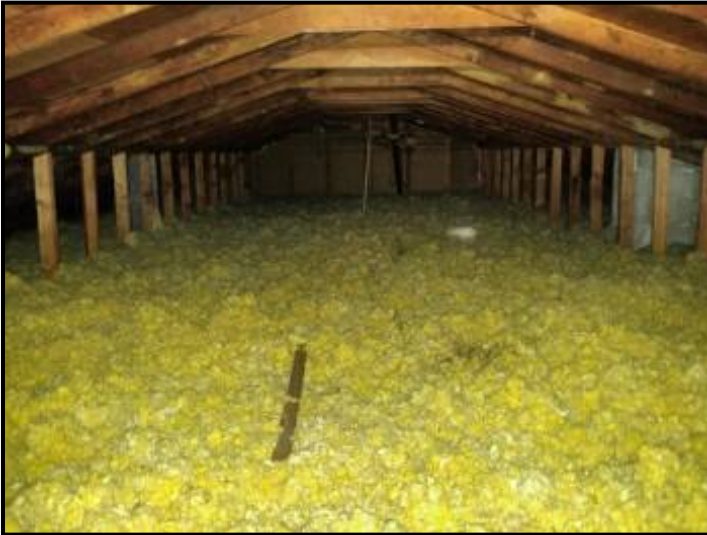
- Attic partially traversed due to high insulation levels.
- Fiberglass Insulation
- Roof ventilation appears inadequate. Consult a roofing contractor for further evaluation.
- Exhaust fan duct appears to terminate in attic. Have duct routed to exterior to minimize moisture an possible development of mold.
- Stick framed roof construction. This construction style is built on site and utilizes a ridgeboard at the peak for the rafters to connect to.
- Plywood/OSB sheathing roof construction

Long shot of attic. Dry at time of inspection
