Octopus Home Inspections, LLC

Your Property Inspection Report

8888 SE Example St, Portland, OR
Inspection prepared for: Example Report
Date of Inspection: 5/19/2015 Time: 12:00
Age of Home: 1971 Size: 1700
Weather: overcast

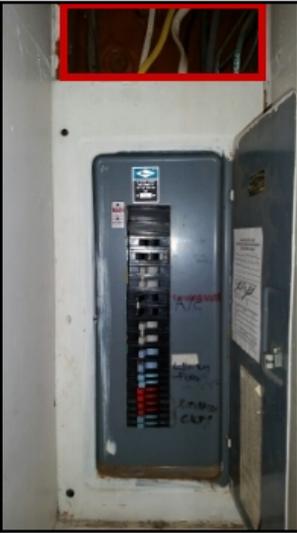
Electric, Heat, Water Heater		
Page 27 Item: 1	Electrical Panel	<ul style="list-style-type: none"> • There is a Zinsco service panel present. Zinsco components are prone to problems that can lead to failures, lack of proper protection of circuits and other serious issues, including fire and electrocution. We cannot definitively call this panel defective, but recommend, for your peace of mind, to consult a qualified electrical contractor to get their opinion on this matter.

<p>Zinsco service panel. Recommend removal due to age and inherent problems with materials used. panel screws missing. Unshielded wiring above panel.</p>		
Page 29 Item: 2	HVAC Unit	<ul style="list-style-type: none"> • Furnace plenum in garage made of plywood. This is a danger due to the combustibility of wood. Recommend replacement by a qualified HVAC professional. • Supply register located in garage at base of furnace plenum. This should be removed and the hole should be sealed as to not allow volatile organic compounds (VOC's) to enter the home. Recommend repair by an HVAC professional.

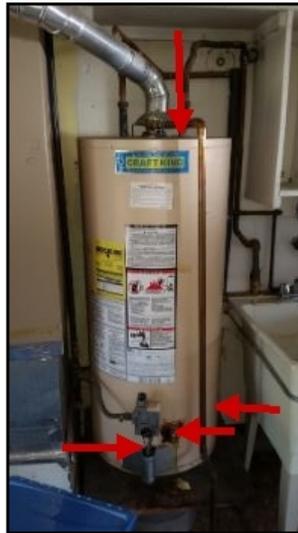
Page 31 Item: 3	Water Heater	<ul style="list-style-type: none"> • Water leak noted at water heater. • Corrosion noted at top of water heater. This may be a sign of poor or incomplete combustion exhaust draft. This is dangerous because carbon monoxide can build up in area and cause respiratory harm to those in contact. Recommend hiring a plumber to inspect further.
-----------------	--------------	-----------------------------------------------------------------------------------------------------------------------------------------------------------------------------------------------------------------------------------------------------------------------------------------------------------------------------------------------------------------------------------------

Gas heated water heater in garage. Recommend replacement. Leaks observed.

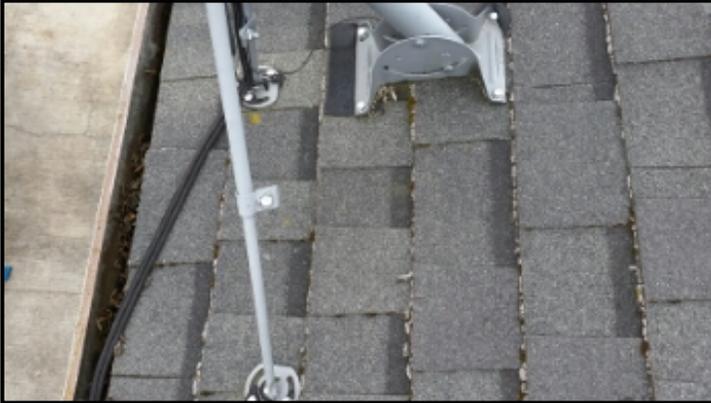
Satellite dish mounted on roof. Self Sealing membrane appears to have been used to avoid moisture penetration. Good Installtion.

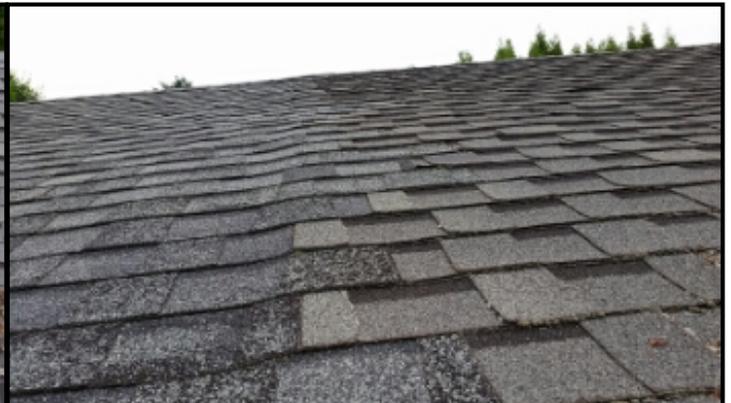
Roof covering change where addition roof meets older roof covering.

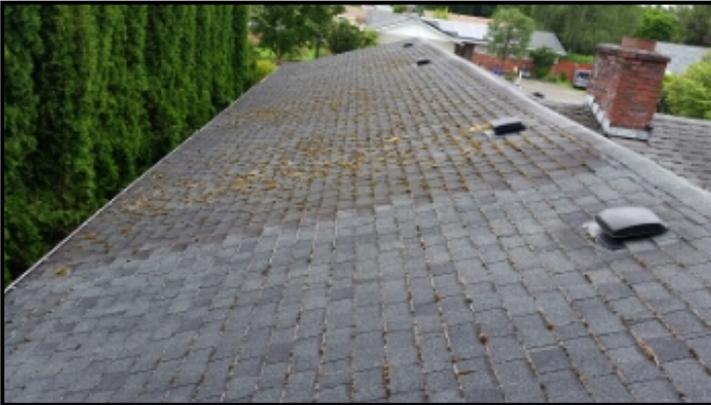
Maintenance Tip: Weather permitting, keep debris cleared from roof valleys to extend life of roof.

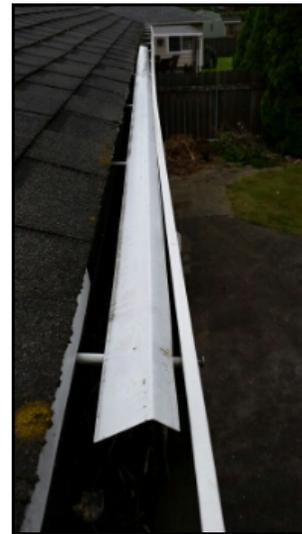
- The roof **drip edge** flashing is in need of repair. Please consult a licensed contractor for further review and repair.
- "W" flashing used in gambrel **valley**

one or more areas where drip edge flashing has come loose. Recommend having a licensed roofer inspect and repair.

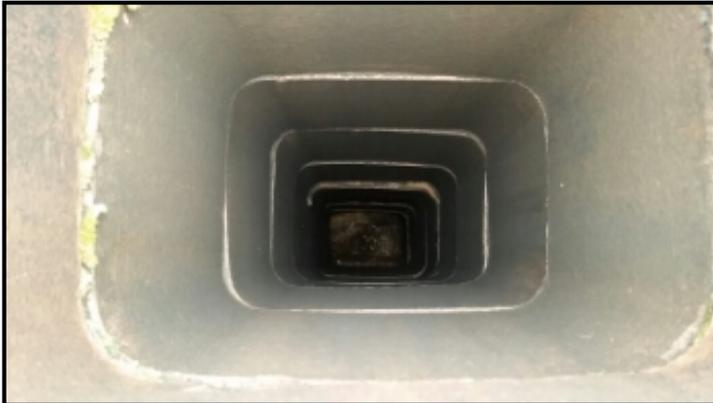
Terra cotta chimney liner. Chimney missing rain cap. Recommend installing chimney cap with spark arrestor to keep birds out and hot cinder off your roof.

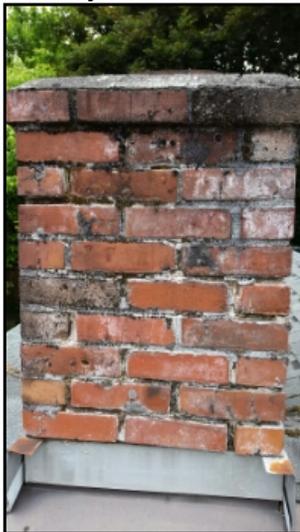
Chimney is made of brick and mortar.

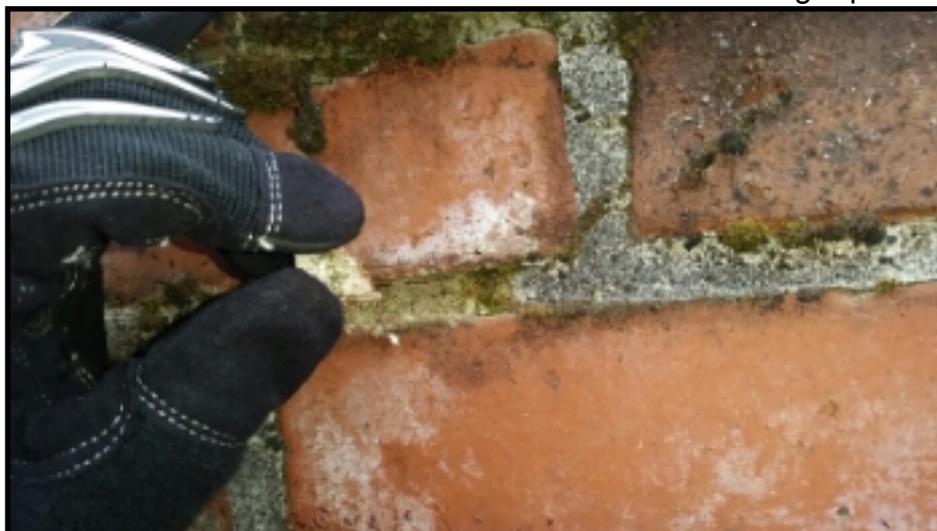
Chimney Mortar shows sign of deterioration. Recommend having repaired as necessary.

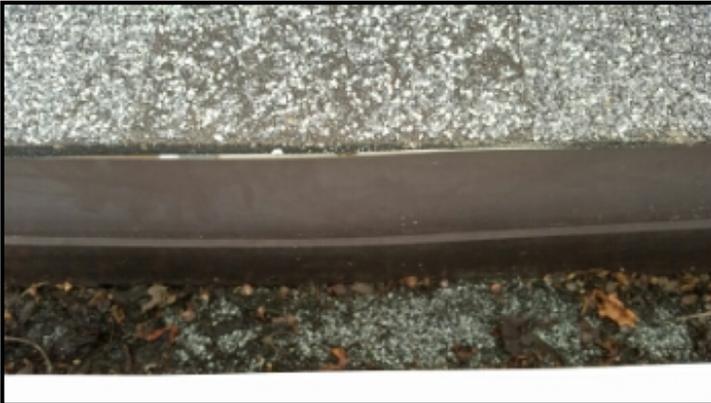
Gutter not under drip edge. possible opportunity for rafter tail dry rot. Recommend having them re-secured.

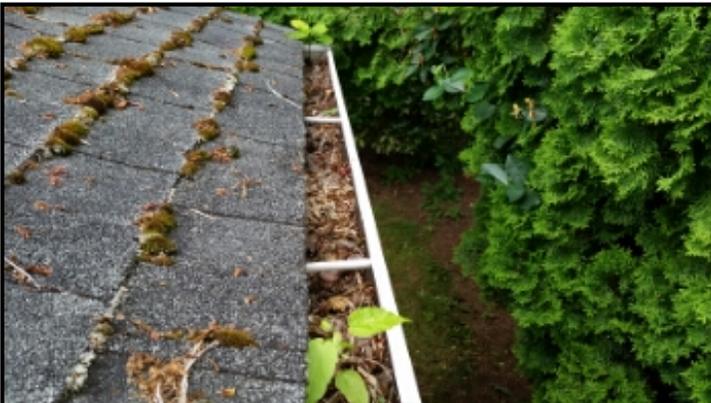
Gutters full of debris. Recommend removal of debris in order for water to channel towards the downspout.

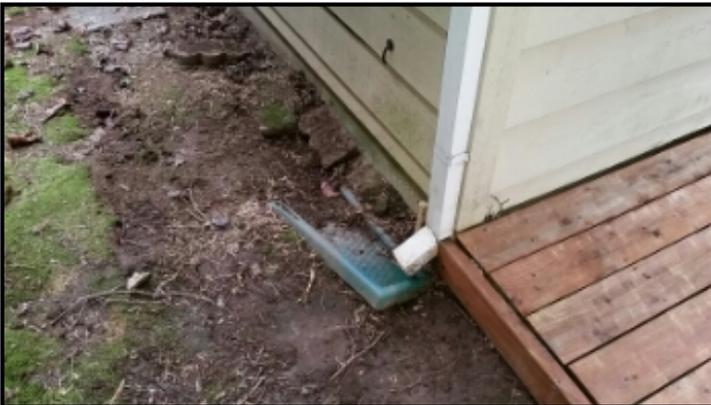
Extensions / Splash blocks missing or insufficient: Install to divert water away from the foundation.

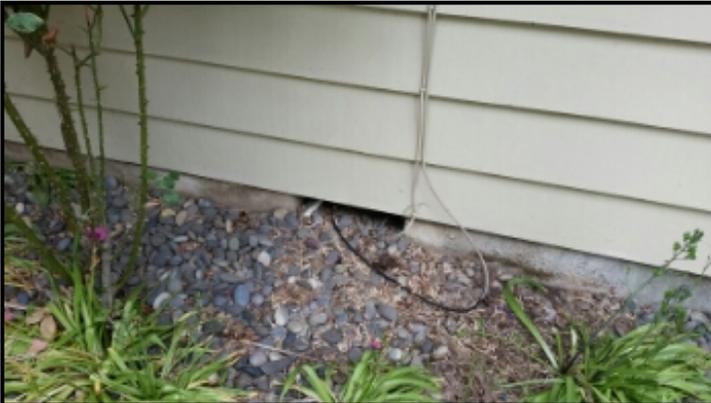
Soil level is higher than the foundation vents. this both blocks the foundation vent and allows water to more easily enter the crawlspace. Both could result in elevated moisture levels in the crawlspace.

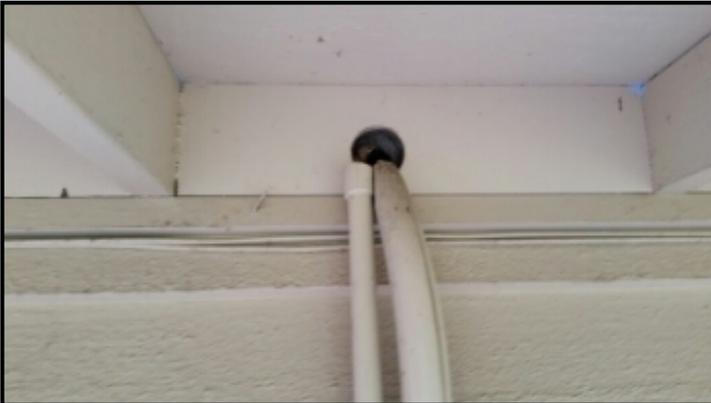
Air conditioner coolant and power access hole. Conduit stops short of hole and should be reviewed by electrician for possible wear on cable. Recommend sealing

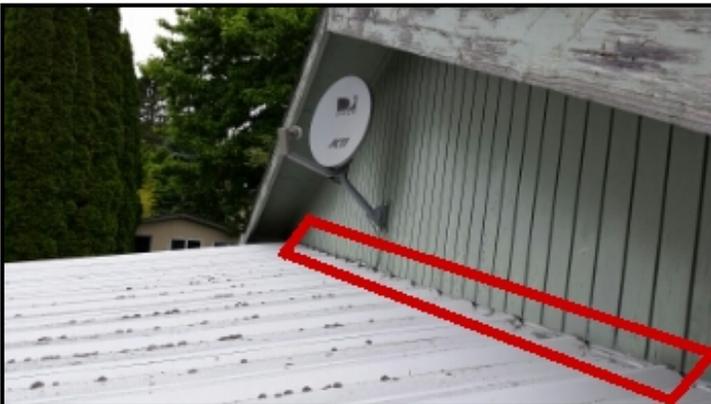
Shed roof flashing missing. This will invite rot. Recommend hiring a contractor to install in order to avoid water intrusion between ledger board and siding.

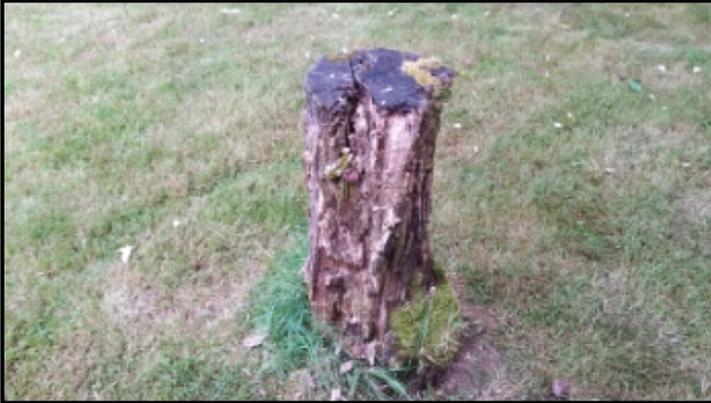
Stump in back yard may be hosting wood destroying organisms (WDO). recommend removal and treatment of soil by a professional exterminator

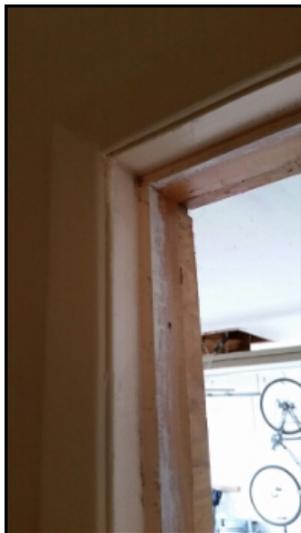
Garage-house door weather strip missing.

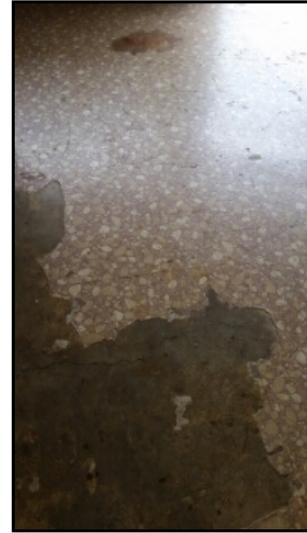
Minor settlement cracks in garage observed where linoleum had peeled up.

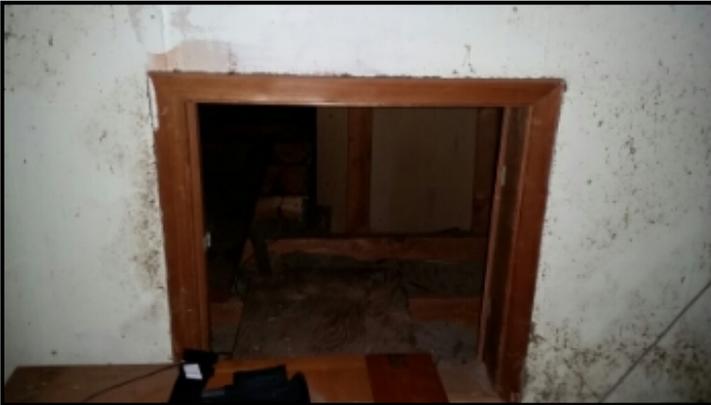
Access door to attic found open. This should be closed to slow the course of fire that may start in garage.

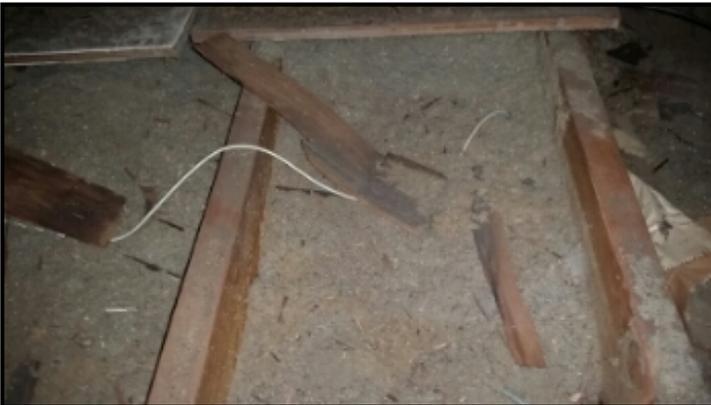
Cellulose Insulation

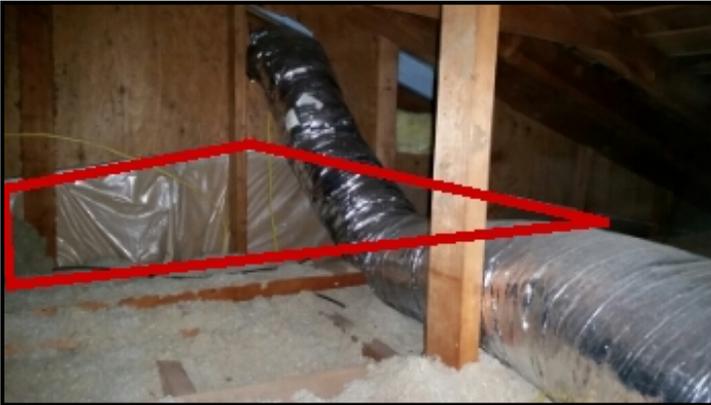
Duct to addition and uninsulated kneewall. Recommend having kneewall insulated to avoid heat loss.

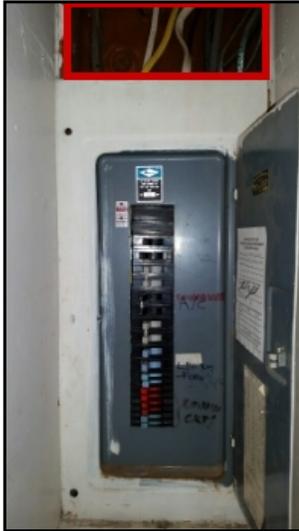
- Access to panel box blocked; interior not evaluated due to safety issues.
- Panel cover screw(s) missing.
- Wiring and breakers not inspected. Access blocked.
- Unshielded wiring above electric panel. Recommend shielding wires from accidental contact.
- **There is a Zinsco service panel present. Zinsco components are prone to problems that can lead to failures, lack of proper protection of circuits and other serious issues, including fire and electrocution. We cannot definitively call this panel defective, but recommend, for your peace of mind, to consult a qualified electrical contractor to get their opinion on this matter.**

Zinsco service panel. Recommend removal due to age and inherent problems with materials used. panel screws missing. Unshielded wiring above panel.

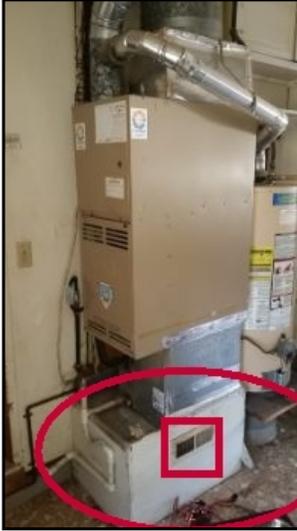
Gas furnace in garage.

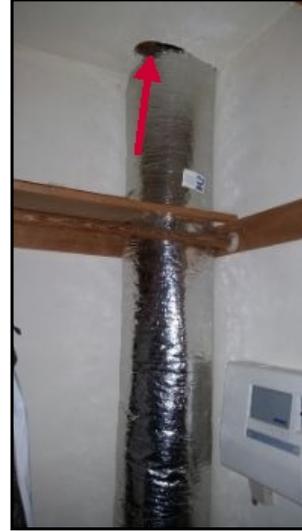
Supply duct to addition has an oversized hole and should be sealed to avoid heat loss and possible pest intrusion.

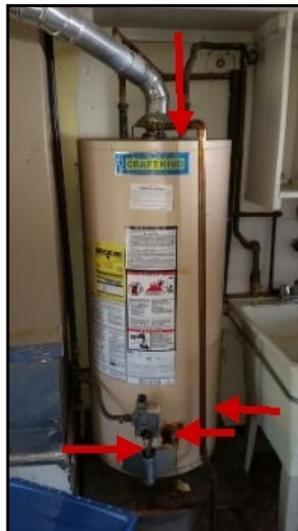
- Corrosion evident; monitor for leaks. Recommend replacement of this unit. It has reached the end of its service life.
- Rust noted around base of water heater. This water heater should be replaced due to age and obvious exterior signs of rusting.
- Flue Pipe of gas water heater loose or corroded. Repair immediately to prevent carbon monoxide poisoning. Recommend hiring a licensed contractor to make repair.
- Water Source: Public
- **Water leak noted at water heater.**
- **Corrosion noted at top of water heater. This may be a sign of poor or incomplete combustion exhaust draft. This is dangerous because carbon monoxide can build up in area and cause respiratory harm to those in contact. Recommend hiring a plumber to inspect further.**

Gas heated water heater in garage. Recommend replacement. Leaks observed.

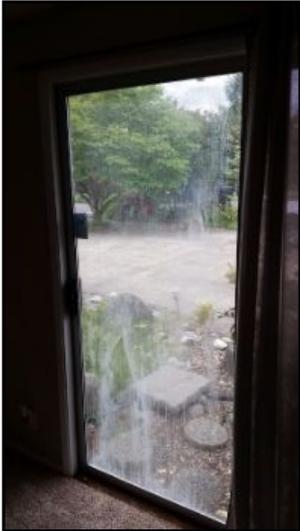
Duel glazed sliding glass door in master bedroom appears to have a broken seal. Recommend replacement.
